RECALL CAMPAIGN

**REF. NO. 145
TESTAROSSA PASSIVE RESTRAINT
SYSTEM**

MARCH 1989

Recall Campaign No. 145
Testarossa Passive Restraint System

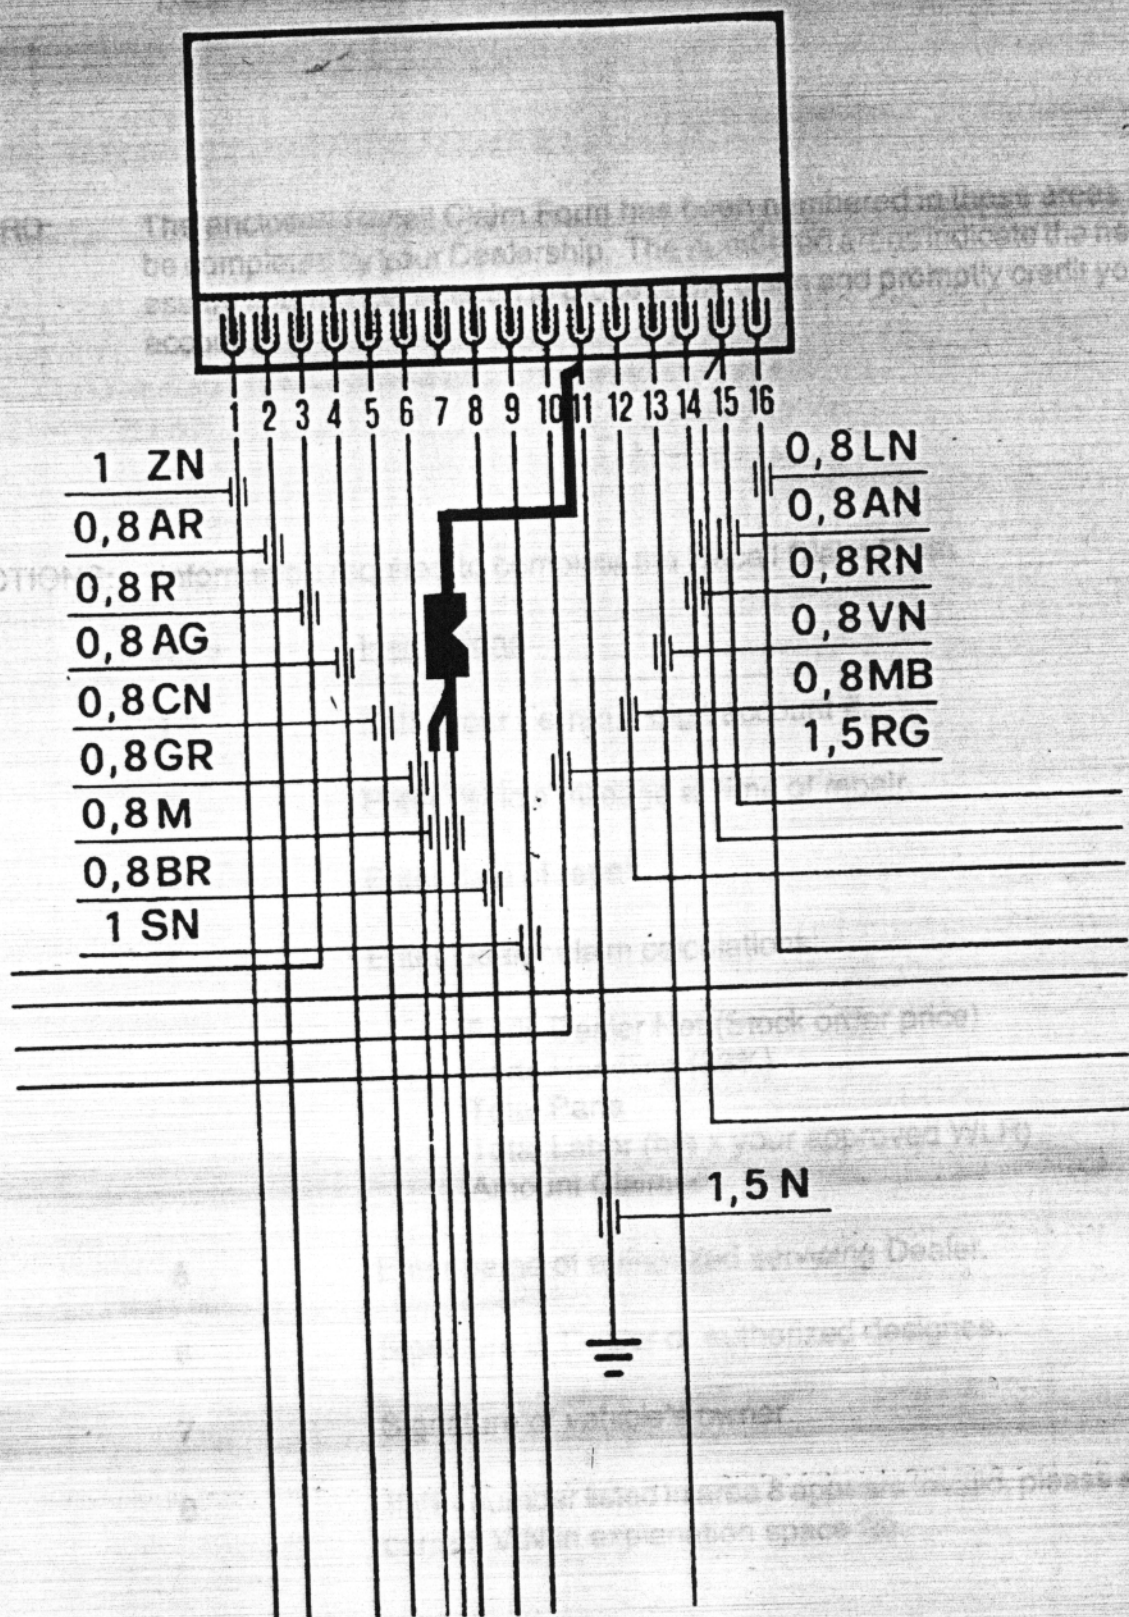
FIGURE 1

THE MODIFIED ECU CANNOT BE FITTED ON VEHICLES WITH C.N. LOWER THAN 72631 WITHOUT CERTAIN CHANGES TO THE ELECTRICAL WIRING GOING TO THE PASSIVE SEAT BELT ECU'S AS DESCRIBED BELOW. THE MODIFIED ECU P.N. 4561 IS THE ONLY TYPE NOW AVAILABLE AS A SPARE PART AND CAN ONLY BE FITTED TO EARLIER VEHICLES (C.N. 72631) IN PAIRS. BOTH LEFT AND RIGHT SIDE MUST BE REPLACED TOGETHER, FAILURE TO DO SO WILL DAMAGE NEW ECU'S.

When fitting the late type Passive Safety Belt ECU's P.N. 4561 to a vehicle fitted with the early type ECU P.N. 61555000, (C.N. lower than 72631) the electrical wiring must be modified in the following manner:

1. Turn off Battery Master Switch.
2. Remove electrical plugs from both left and right ECU's located in center console.
3. Remove the 2 wires going to terminal No. 7 of the electrical plug and join together with wire going to terminal No. 11 (Refer to Figure 1).
4. Perform the above operation for the other ECU.
5. Replace ECU's with new type and reconnect electrical plugs.
6. Switch on Battery Master Switch.
7. Check operation of Passive Seat Belt System.
