Service Bulletin

SB 10-22
6/15/88

SUBJECT: ENGINE/GEARBOX ASSEMBLY
VEHICLES: TESTAROSSA

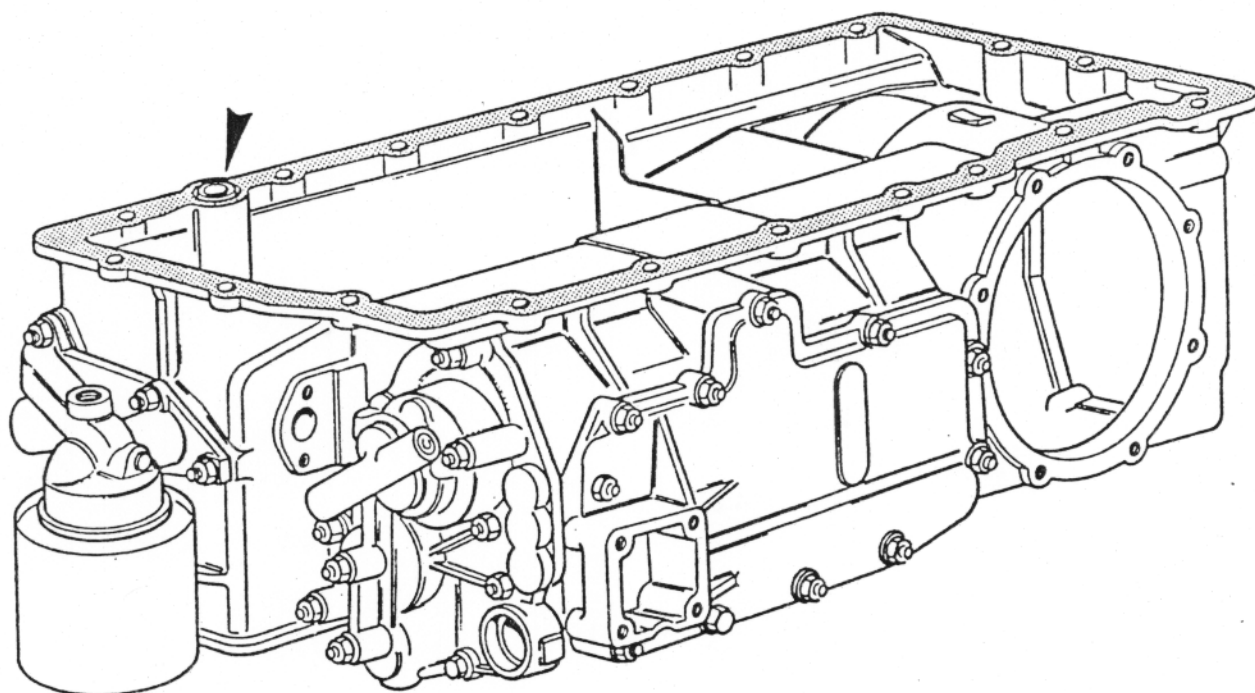
You are informed that cases of blockage of the engine oil lines have occurred (with serious consequences to the engine) owing to the excess sealant used on the contact surfaces between the gearbox casing and the crankcase.

It is therefore recommended that, when fitting the gearbox after overhaul or other servicing (e.g. dismantling oil pump chain) that you spread only a film of paste on the contact surfaces and in particular without any excess in the zones of the main oil gallery (see fig.).

If the operation also entails dismantling of the heads, the centering stud (P.N. 124382) on the engine block should be removed and you should check, using a jet of air under pressure, that the oil ways are clear.
