Service Bulletin

SB 10-8
1-12-83

SUBJECT: Modification of the Blow-By System
VEHICLES: 308 Fuel Injected Engines (308 GTBi, GTSi & Mondial 8)

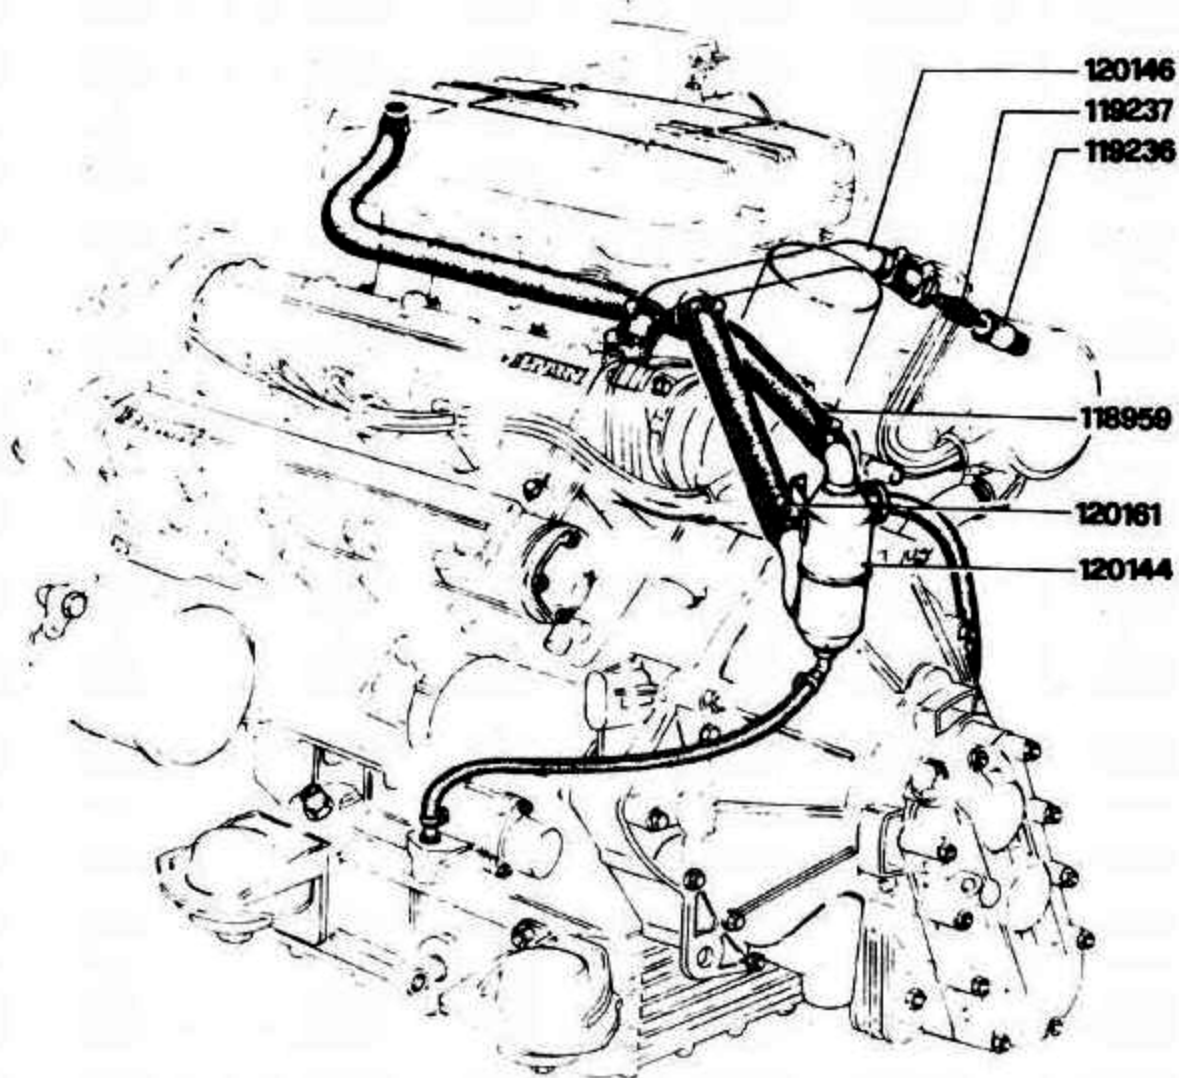
MODIFICATION OF THE BLOW-BY SYSTEM

Should you find any deposit of oil in the air inlet to the engine, after the air cleaner, our suggestion is to modify the blow-by system as shown by the layout.

These modifications, which do not alter the original apparatus and its principles of operation, allow a more effective condensation of the traces of oil transported by the blow-by gases.

- 1) Addition of splash screens in the outlet connections from the engine head covers.
- 2) Wider pipes.
- 3) Shorter drain hose from blow-by separator to engine sump in order to avoid a pocket.

Particular care must be used while fitting hose p.n. 106338 which, after being shortened to 530 mm., must be located underneath the starter motor, WITHOUT THE CLAMP holding it to the clutch housing and arranged so that there is no pocket.
