Service Bulletin

SB 80-6
11-29-79

SUBJECT: HORNS
VEHICLES: 308 GTB (U.S.A. VERSION)

REISSUE OF TECHNICAL BULLETIN #301, DATED 3/17/77

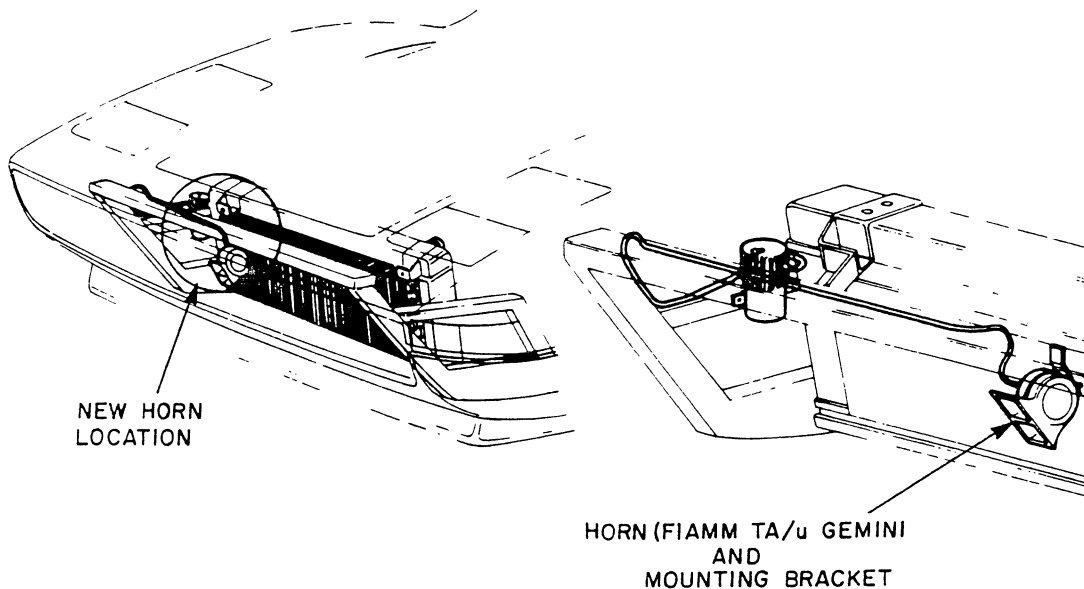
Sound of the horn is too loud inside the passenger compartment.

CAUSE: Location of horn

Installation of a new type horn, ("FIAMM TA/U Gemini") and mounting bracket to the center of the upper front frame bar. (See illustration.)
