Ferrari 328 Intake Airbox-to-Ascending Coolant Pipe Interference: Inspection & Repair

*Carl Rose and David Handa
August 2003*

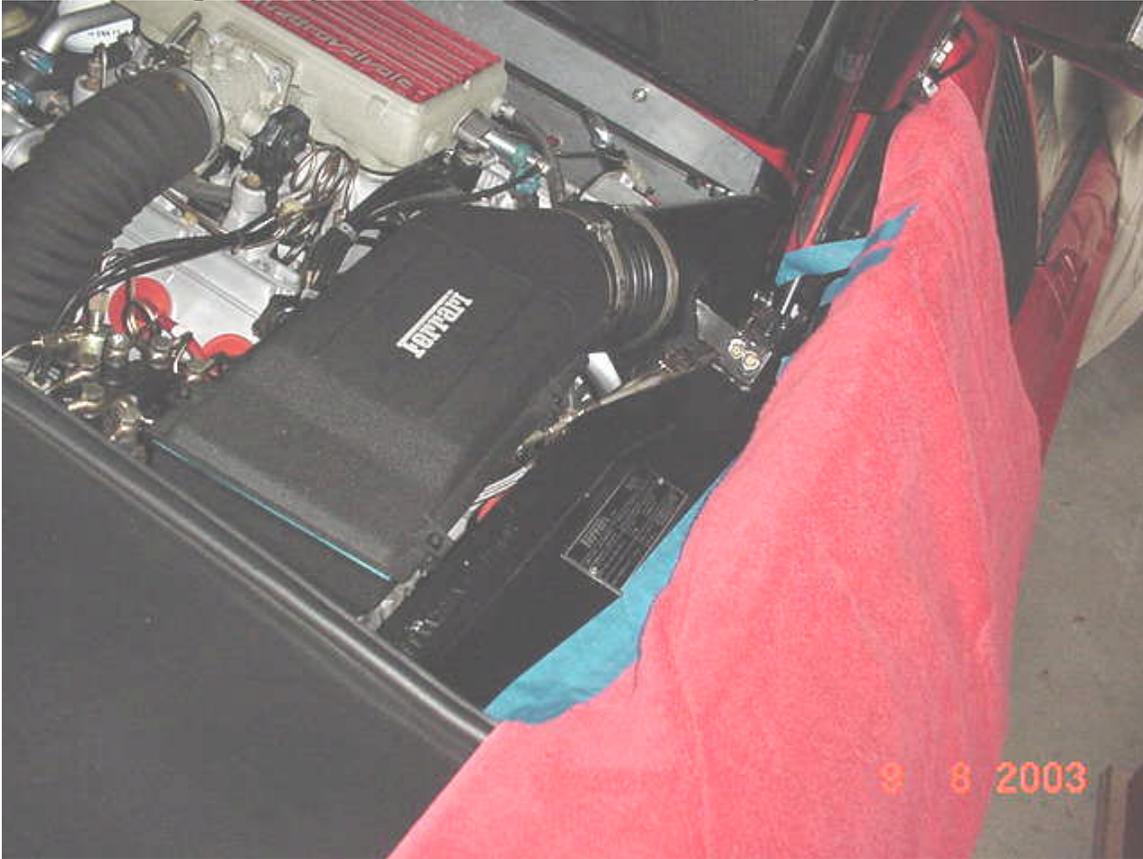
Block front wheels and open decklid. Drape thick towel over rear fender; in pictures this is affixed to engine compartment with low-tack 3M blue tape:

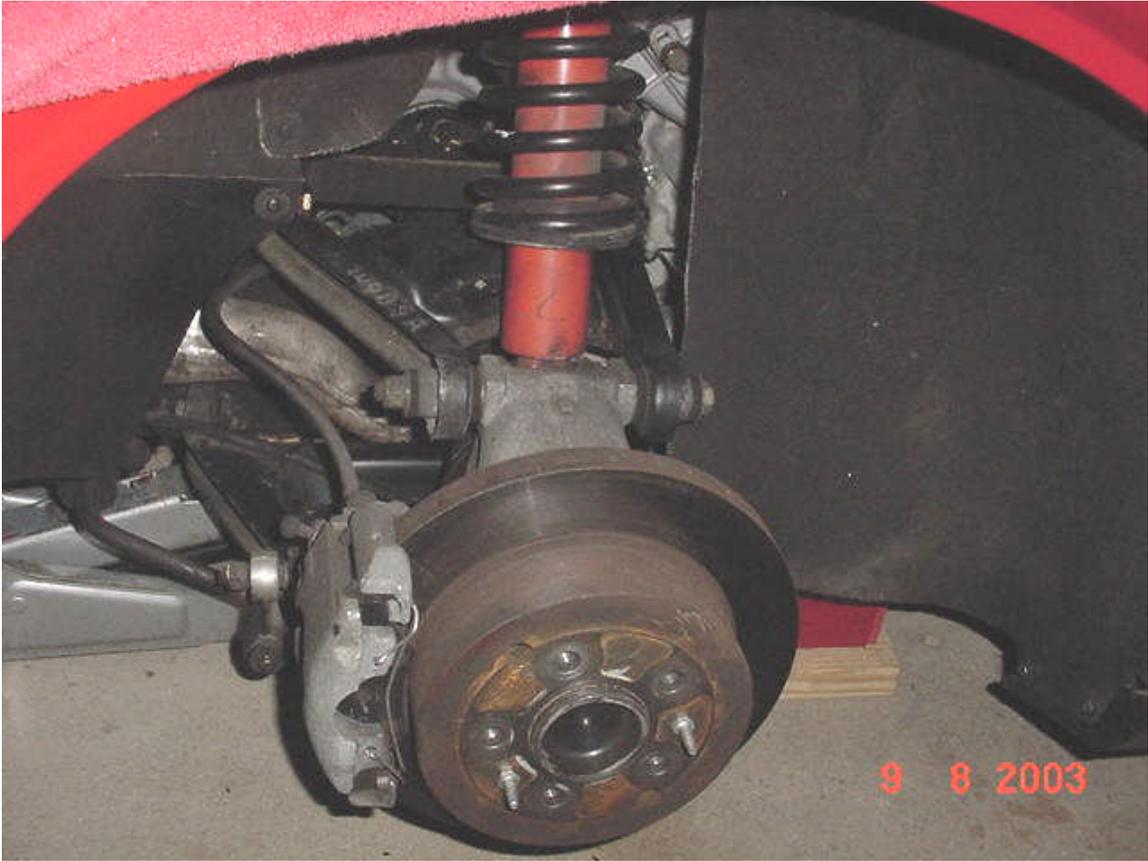
Loosen right rear lug bolts while car is still on ground. Jack right rear up until wheel clears ground and place stand under right rear frame rail. Ensure front wheel blocks have

not shifted. Remove wheel:

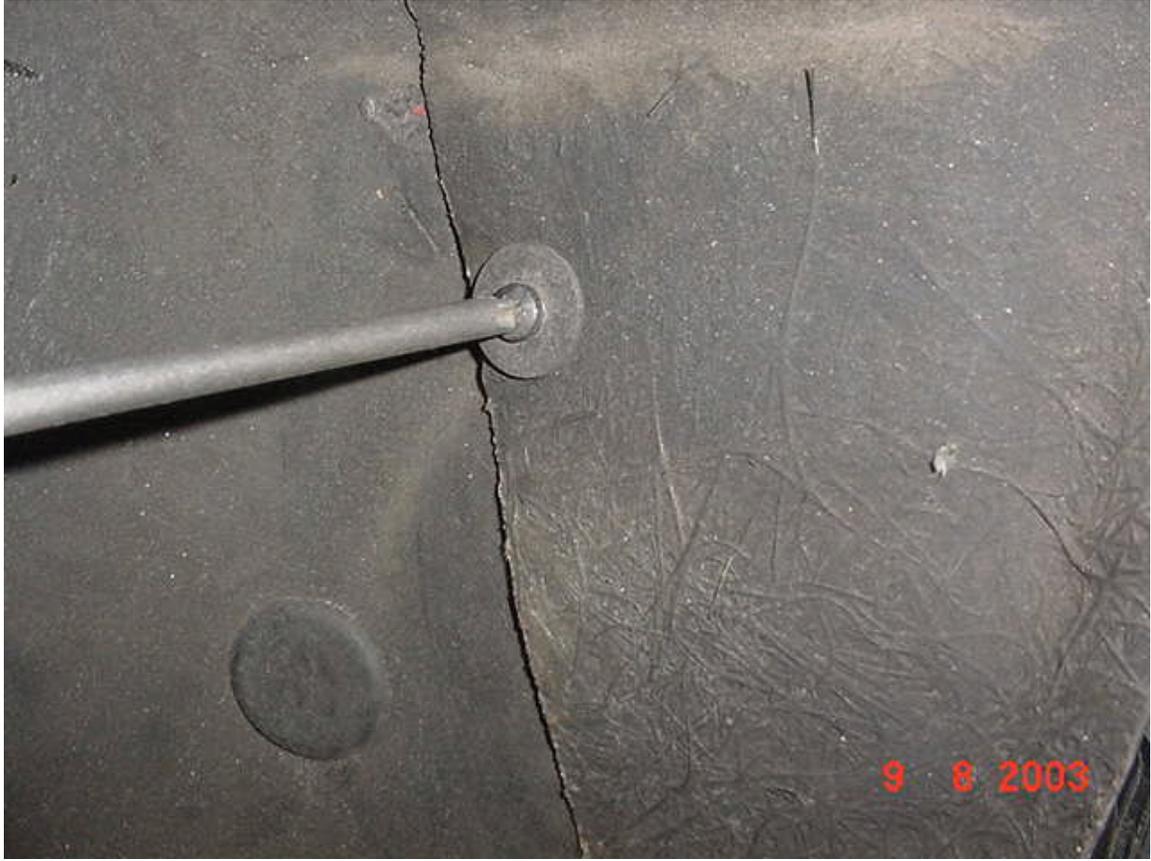
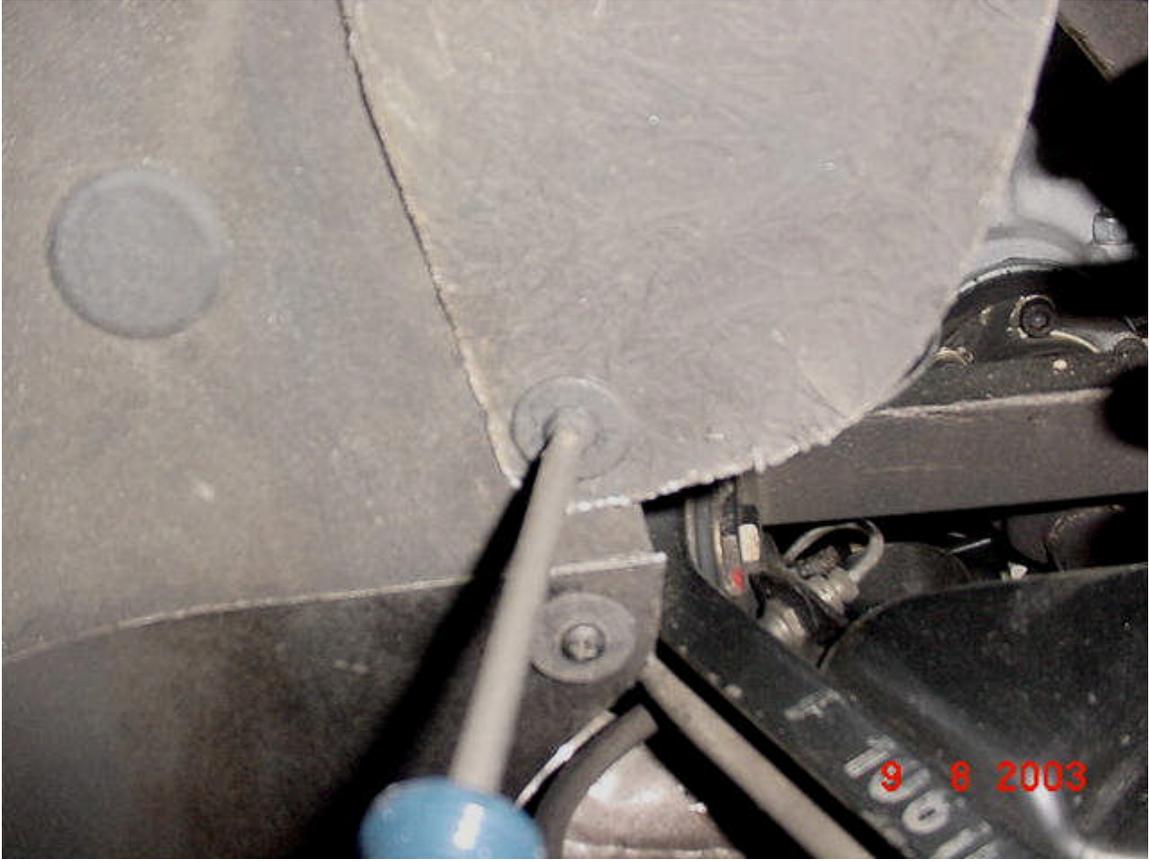
Remove forward portion of inner wheelwell fiberglass shield: three hex screws & large washers at front & top followed by four Phillips screws & washers at rear:

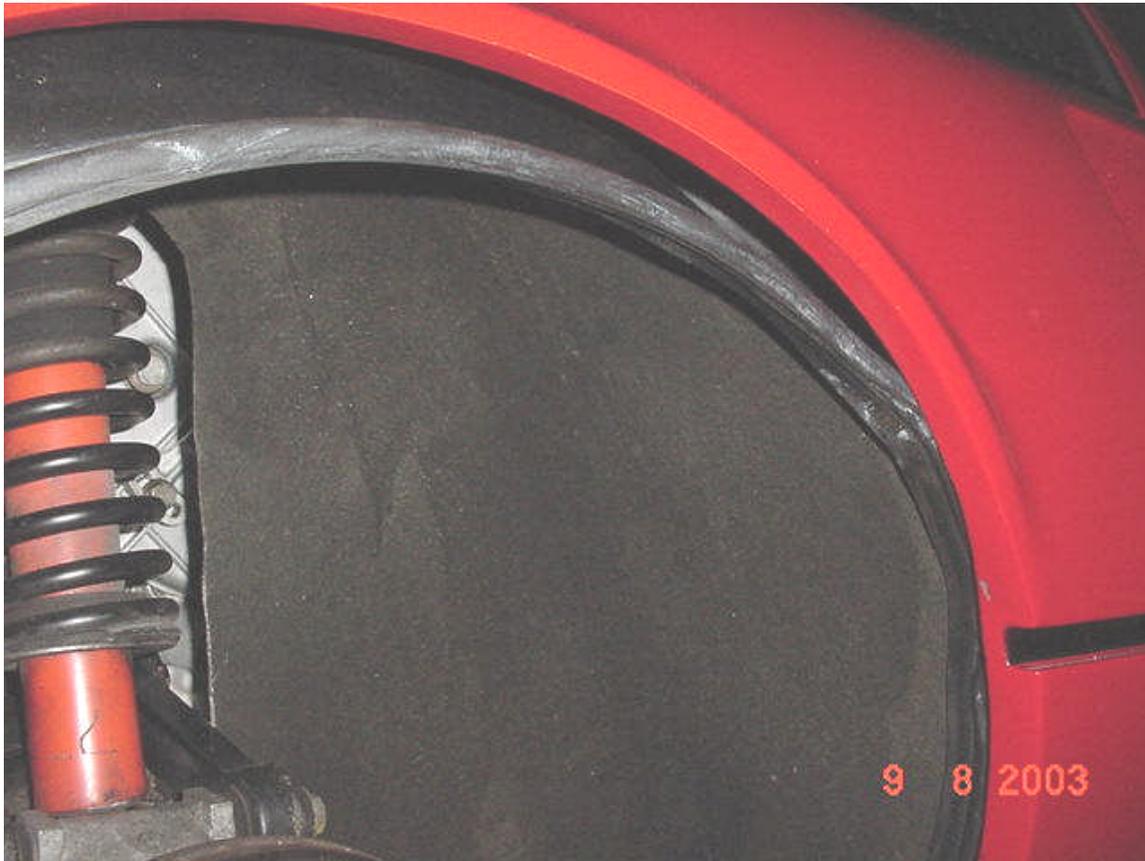
Maneuver shield out:

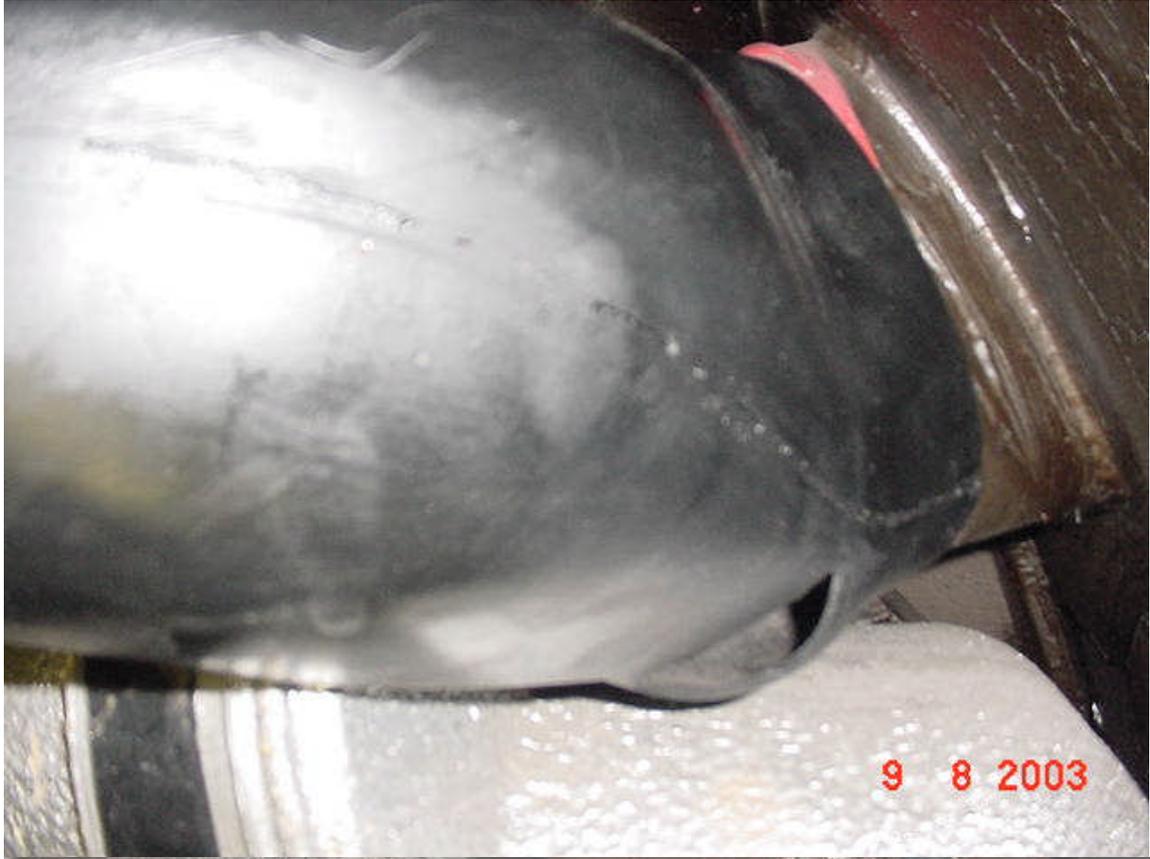
Lower fiberglass intake air scoop ducting can be seen in this picture: proximal end fits over inner fender continuation of external intake, is secured by a small screw underneath rear chassis understructure, then turns upward & connects to airbox via rubber bellows hose:

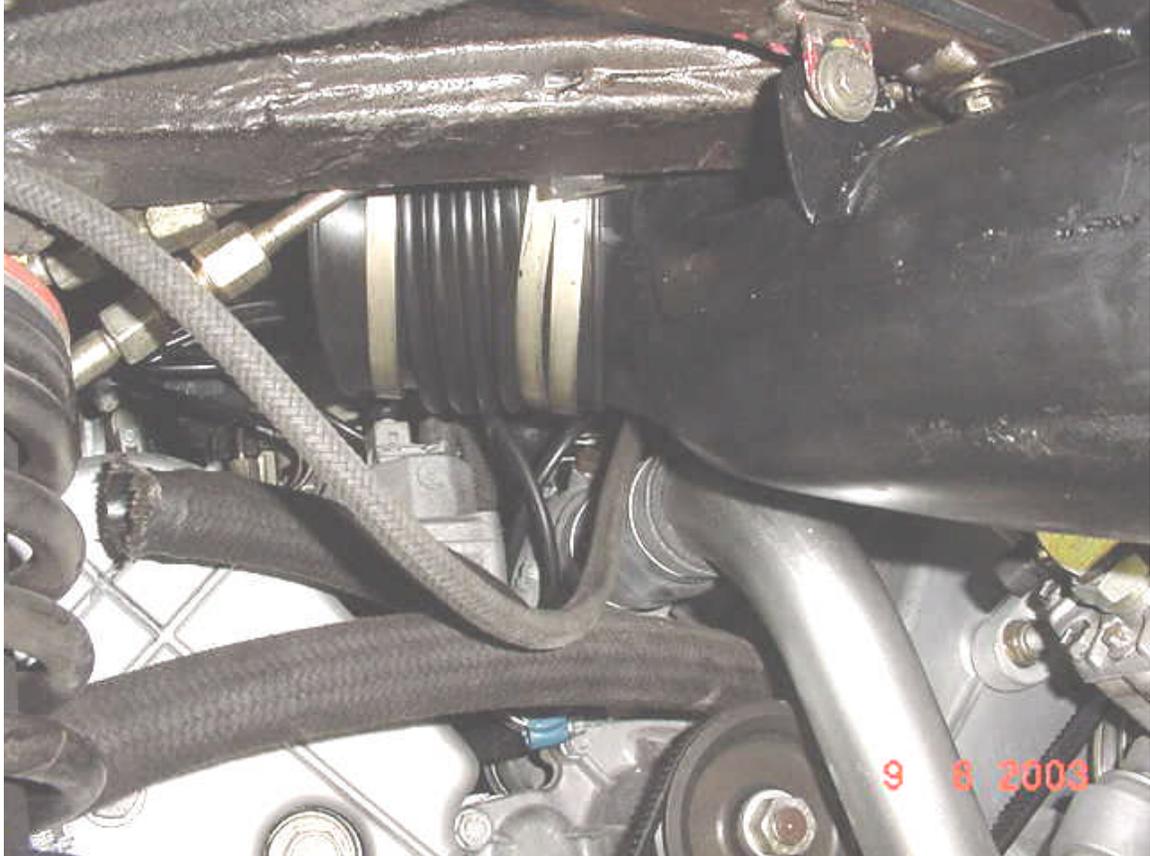
Note the minimal clearance between ascending coolant pipe at terminal bend into water pump and lower aspect of intake ducting. My car had approximately 3-4mm air gap (further discussion later):

At this point I considered cutting a short segment (perhaps 2 inches) of old radiator hose lengthwise & zip-tying circumferentially over cooling pipe at bend to prevent possible future damage. Another option would be to cement a flat rubber strip to the underside of the intake ducting. Picture shows previous area of abrasion on bottom of ducting:

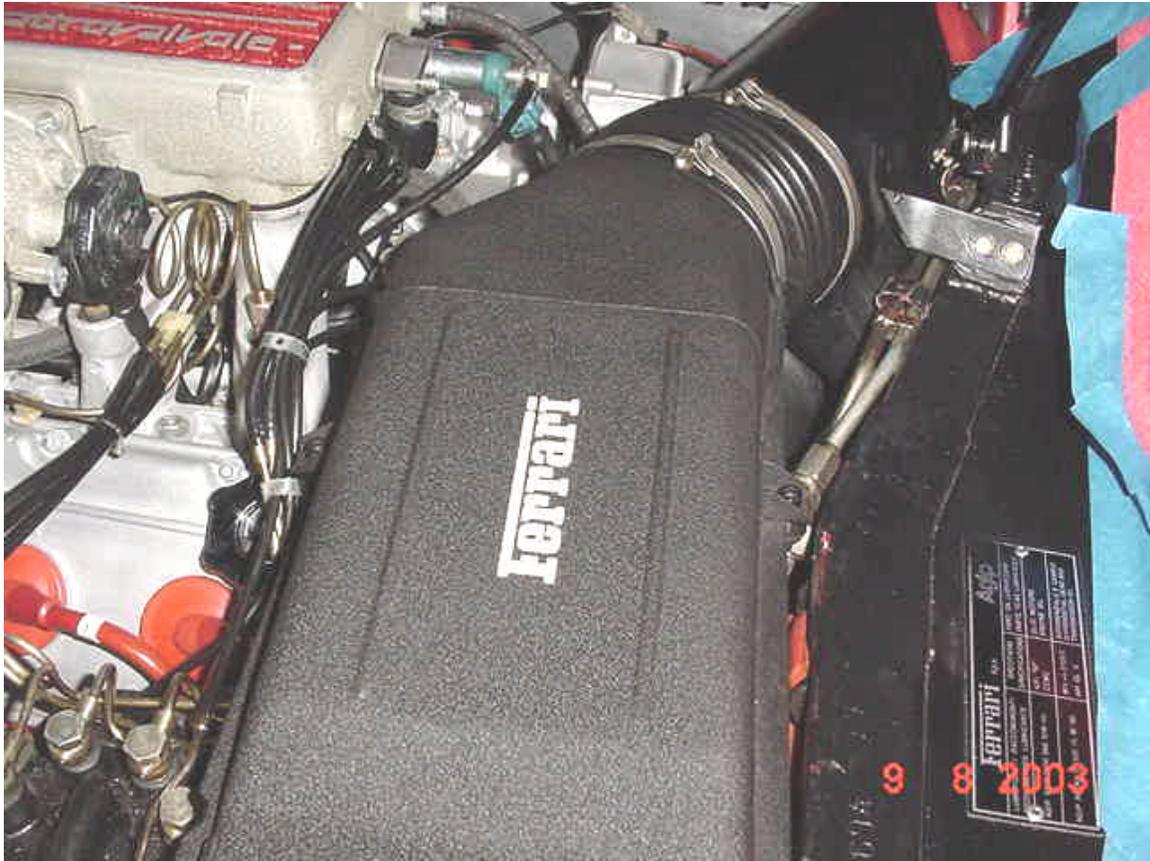
Remove the upper airbox by loosening the large circumferential clamp holding to Bosch FI metering body. Access can be quite challenging depending on orientation of the clamp hex screw; mine was parallel to inner wall of engine compartment. I was most successful using a short 1/4" 6pt 10mm socket with universal joint on 8" extension & approaching from below:

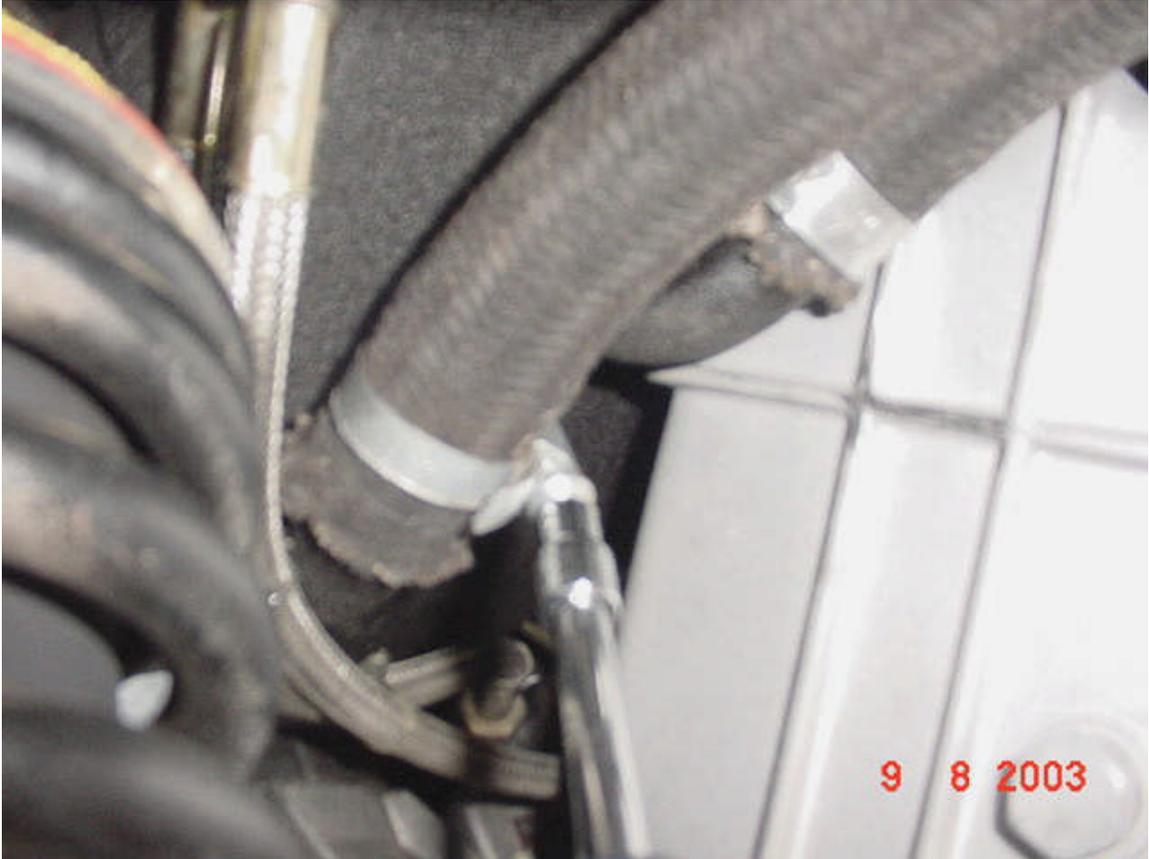
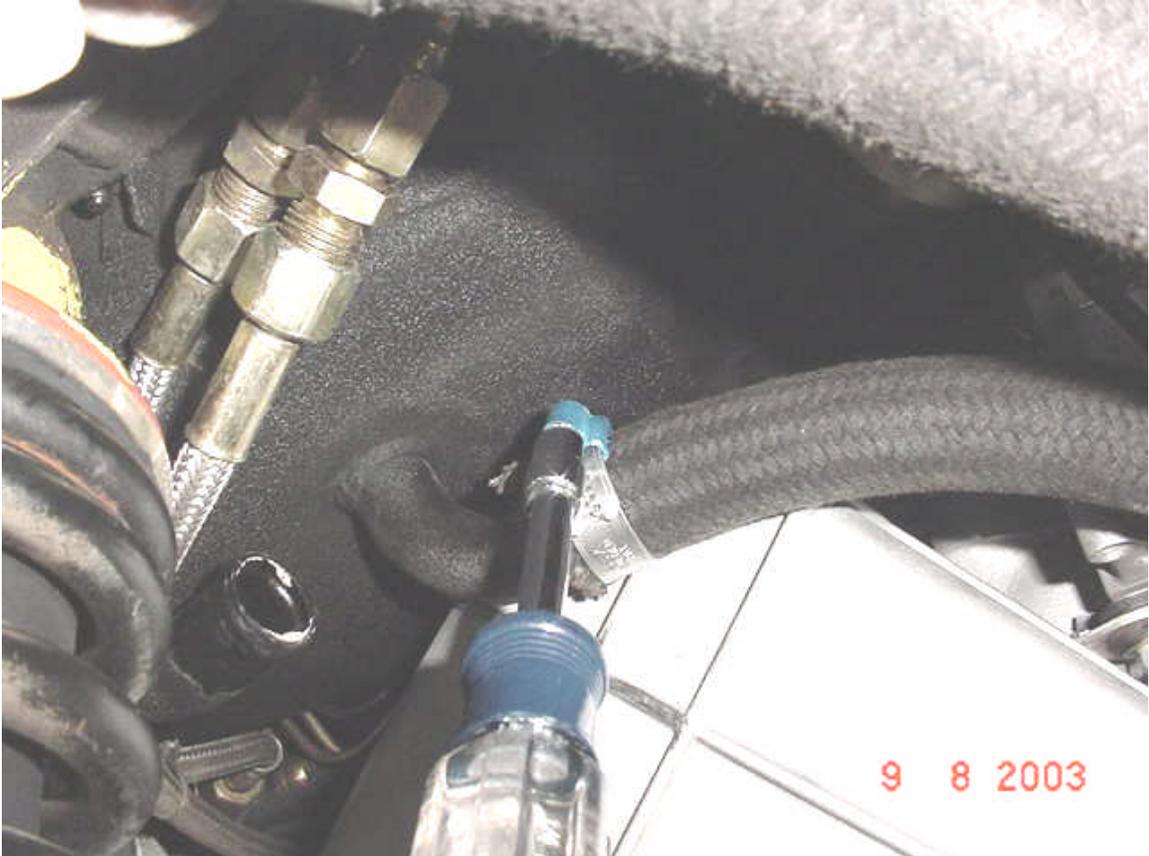
Once loosened, lift the airbox slightly upward. Remove the two hoses that attach to fittings on bottom of airbox: larger uses 7mm hex nut clamp while smaller uses 6mm:

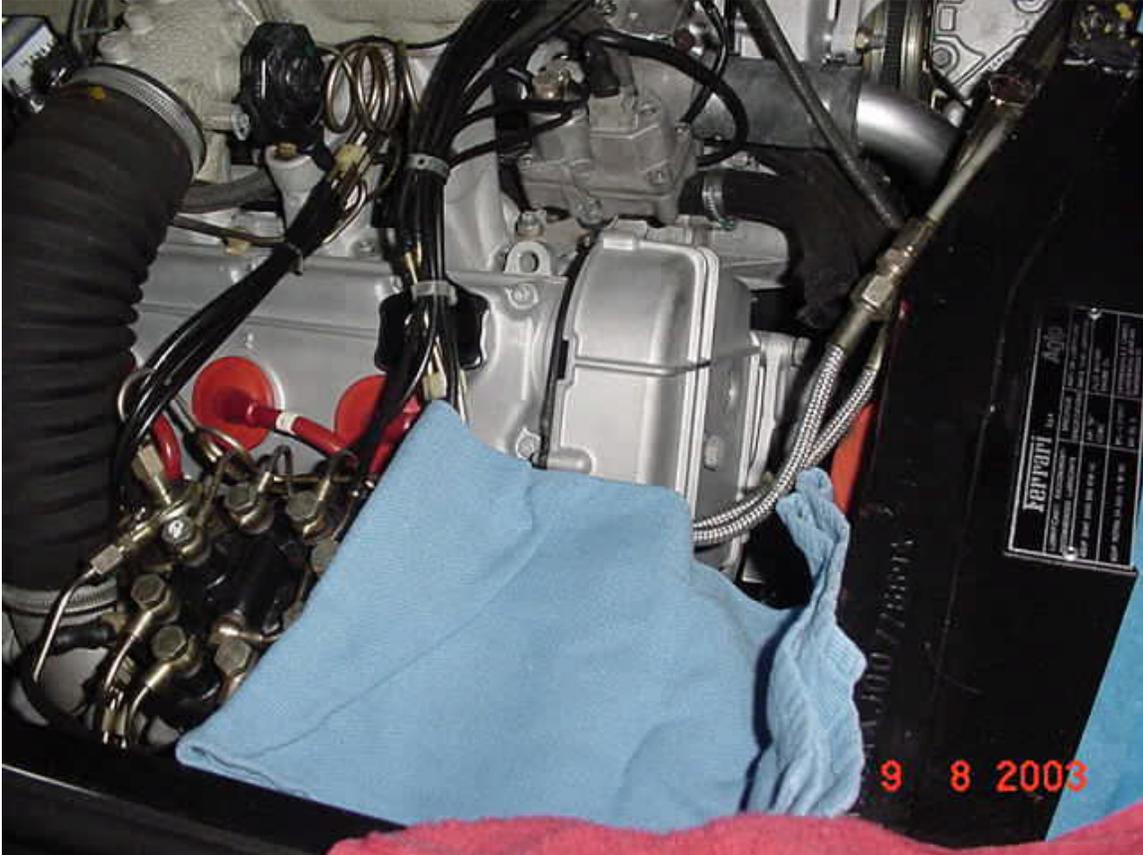
I was able to successfully wiggle the airbox throat from the bellows hose without having to disassemble either cotter-pin circumferential clamp. If very tight, you might be able to compress the cotter pin ends and pull them straight out to disengage clamp band. Remove the airbox & set aside. Place a towel over the metering body intake to prevent dropping anything on plate:

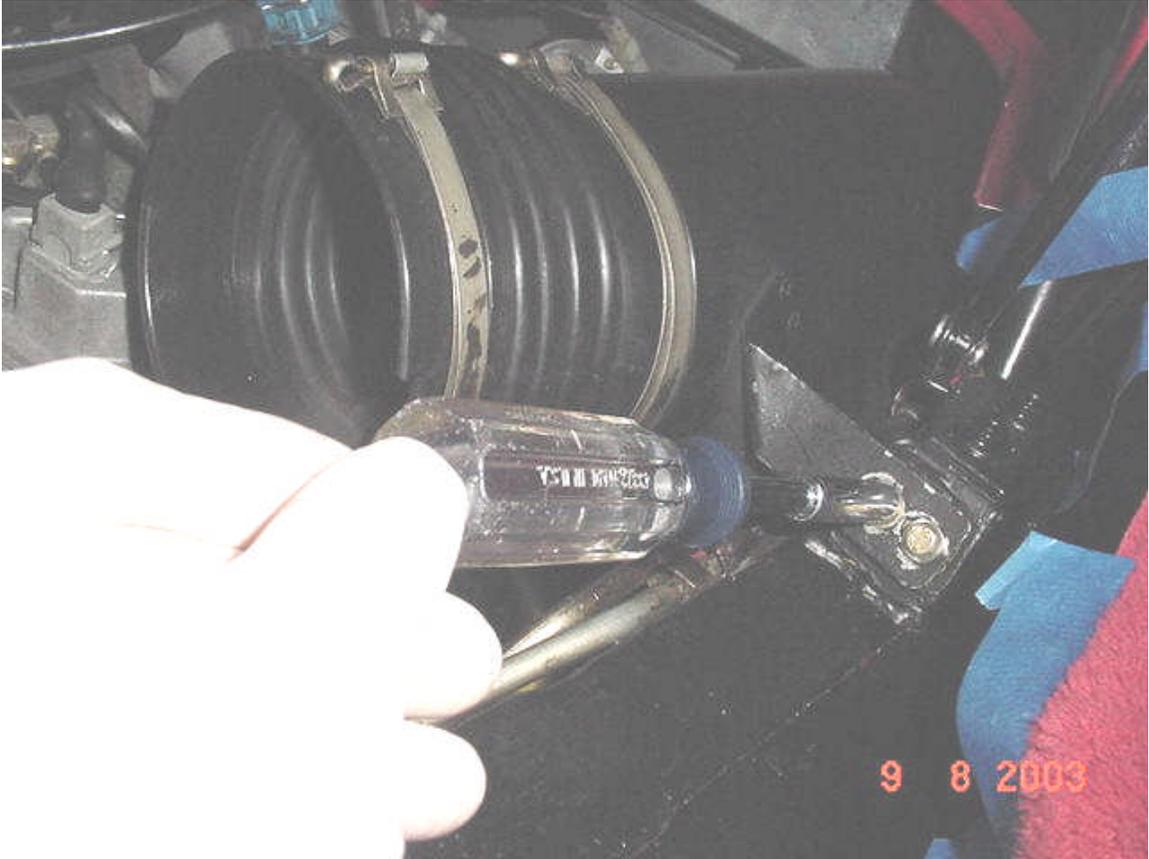
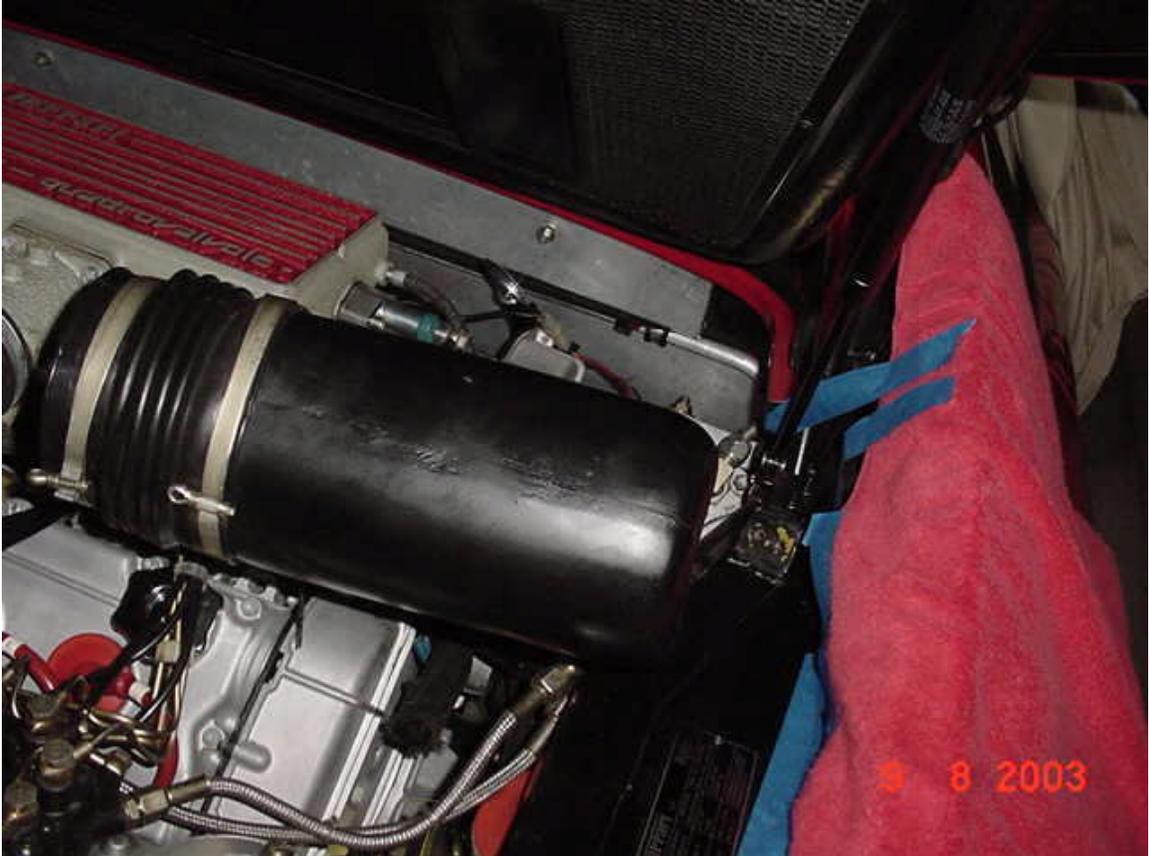
Remove the lower screw and two upper bracket screws & maneuver the intake ducting out from above:

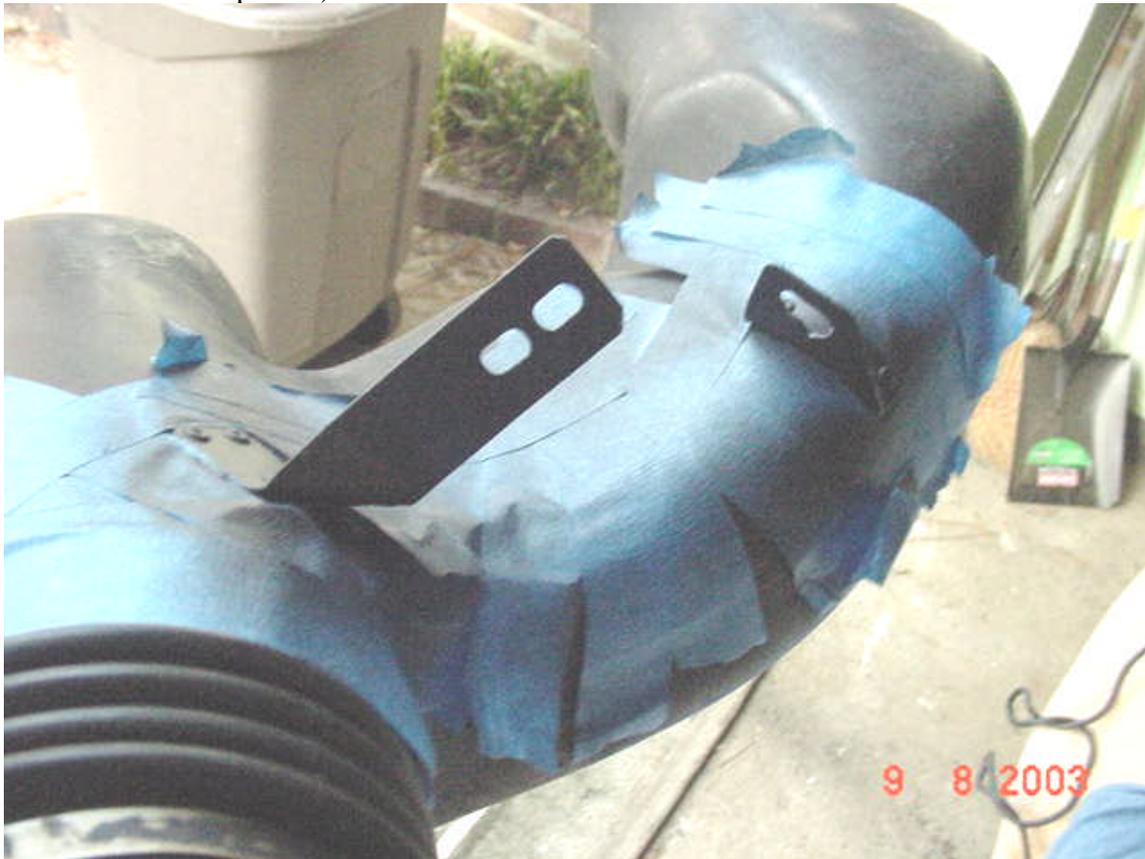
Now is an excellent time to inspect/re-tension the engine accessory drivebelts & right rear brake pads. Check water pump for any signs of coolant leakage. To replace the air filter, unscrew the four allen bolts holding the airbox lid & lift filter out. Install new filter & tighten bolts to “snug”. I elected to repaint the two ducting brackets (originally semi-flat black without primer):

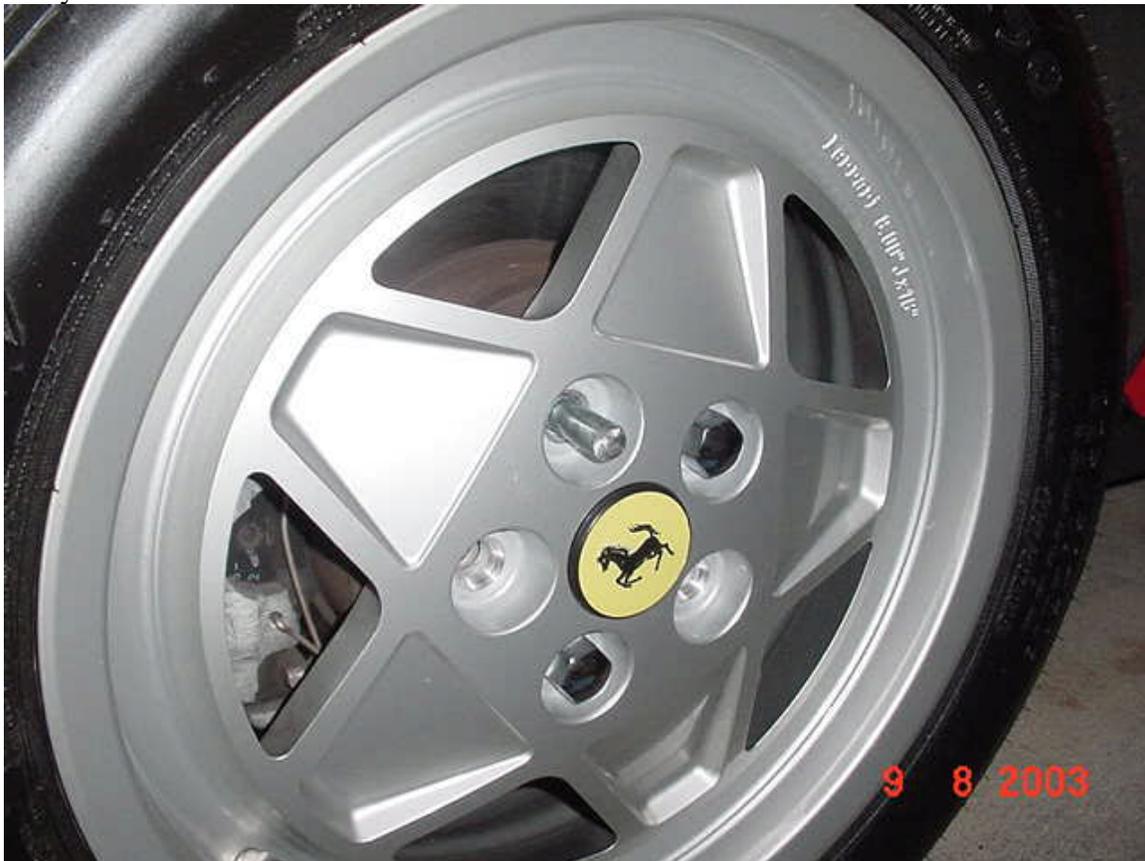
Finally, my car had recently undergone 30K service & was missing lower ducting bracket-to-chassis screw; originally appears to have been a sheetmetal thread-cutting type (unsure of finish/head) but I replaced with the short bolt, washers, and nylon locking nut seen in the pictures (perfectly functional, but I would be interested in the “proper” screw

type if anyone can confirm?). Remainder is reverse of disassembly. I found an awl to be invaluable in locating the chassis holes for the upper wheelwell liner screws. The lug stud guide in the picture – simplifying wheel reinstallation - is courtesy of FC member Mr. Foley:

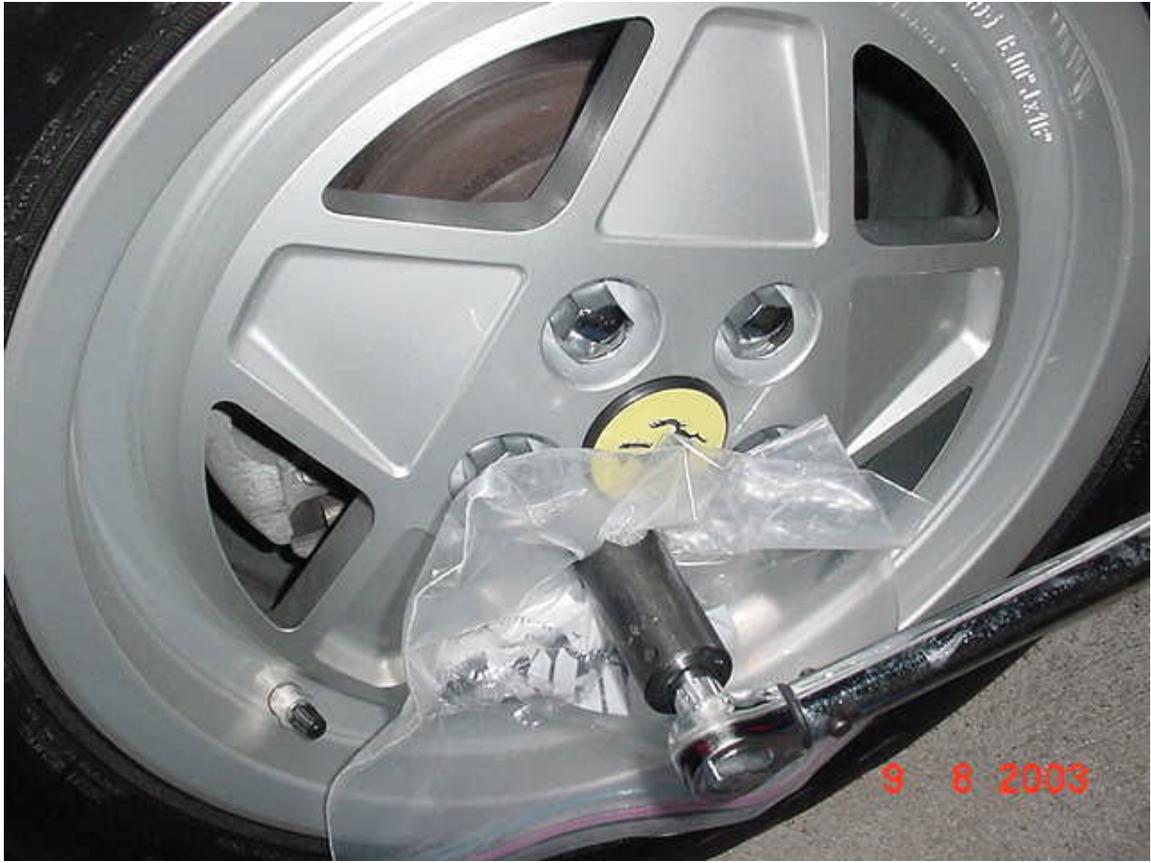
Lower car & remember to torque lug bolts to 72ft/lbs; pictures illustrate Snap-On aluminum-lined socket with plastic freezer bag to protect finish:
