Ferrari 328 Distributor Shaft Seal Replacement

Carl Rose

May 2003

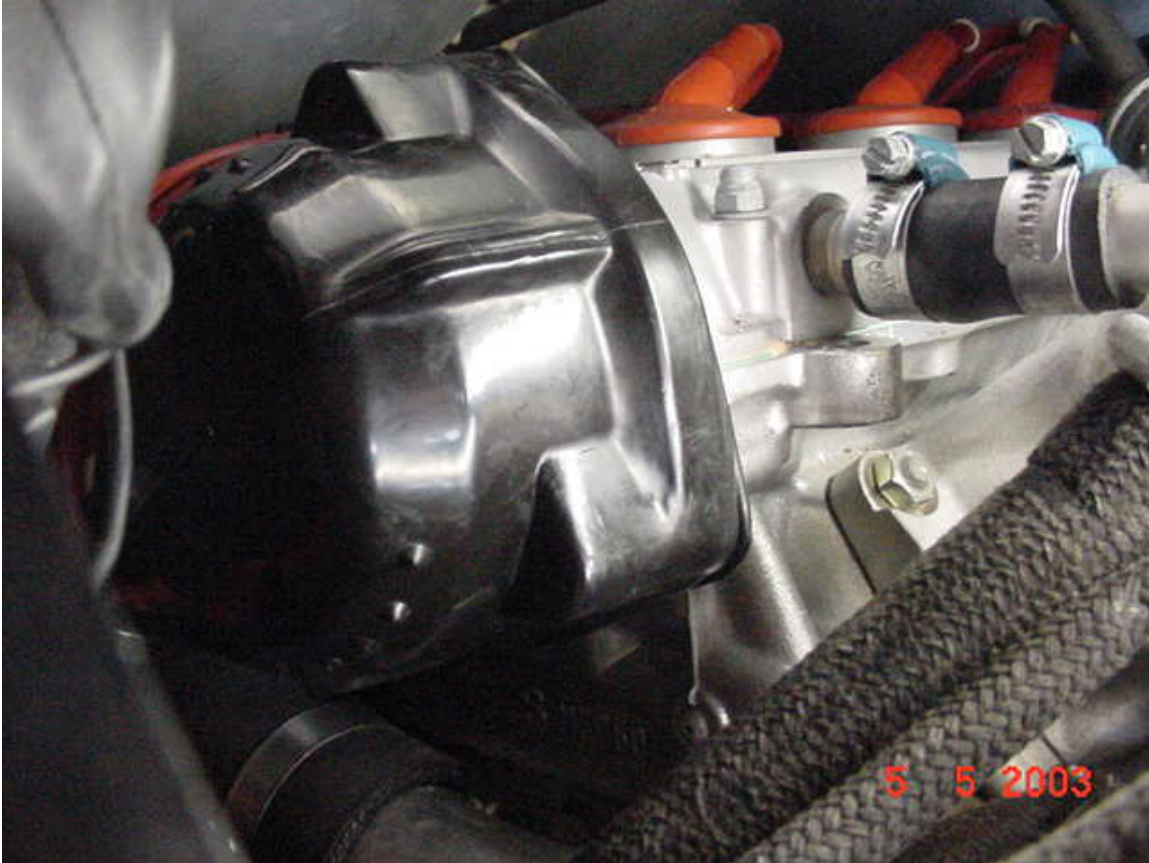
First, protect the car by covering with soft thick towels and taping in place. Begin by sliding back the distributor rubber boot cover:

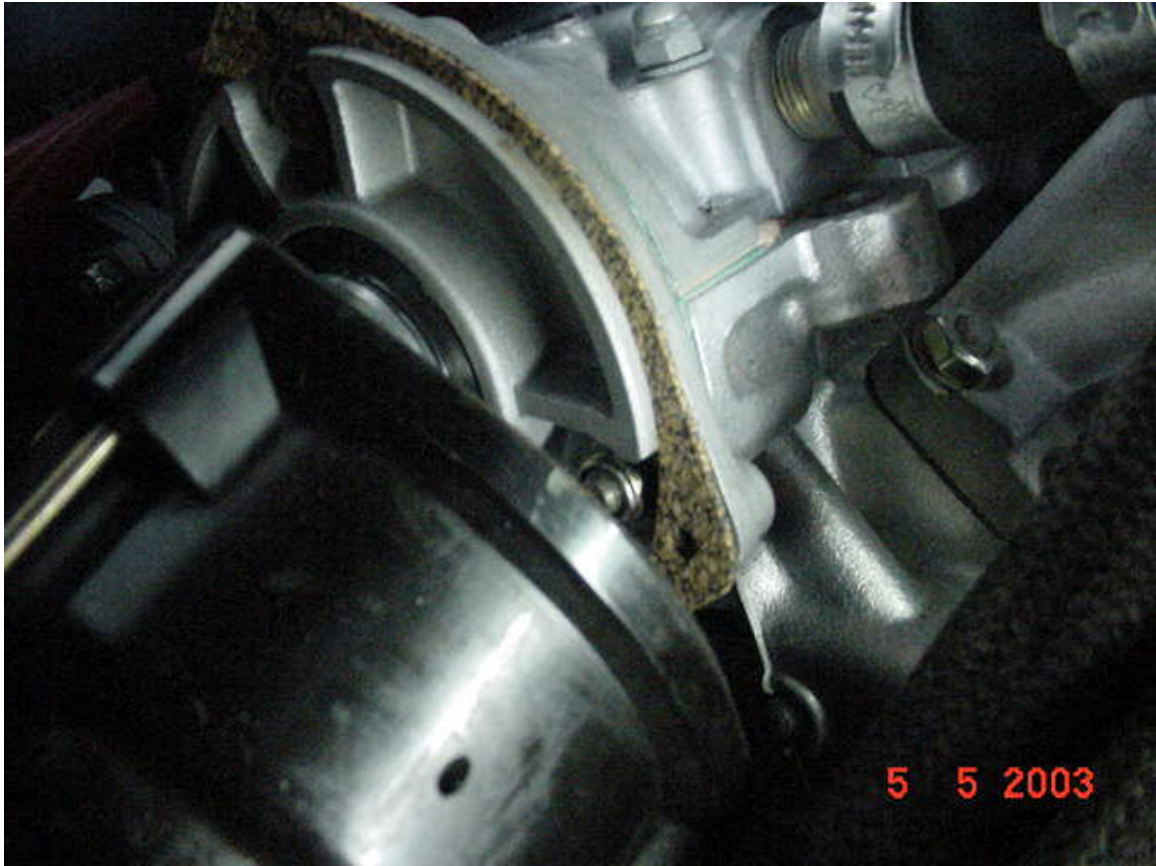
The cap is held in place by three 8mm hex bolts spaced at 120° intervals. The upper two are easy to access, whereas the lower (under the exiting spark plug wire bundle) is far more challenging. I was able to loosen the upper two with an 8mm deep socket, but found an 8mm box end wrench oriented towards the firewall best for the lower. Push the boot away; this lower bolt is removed primarily by “feel”. Fortunately once loosened each easily spun out with fingers (they will not fall out of cap). If yours do not, consider running a tap through the mounting flange (and die over screws) to make reassembly easier.

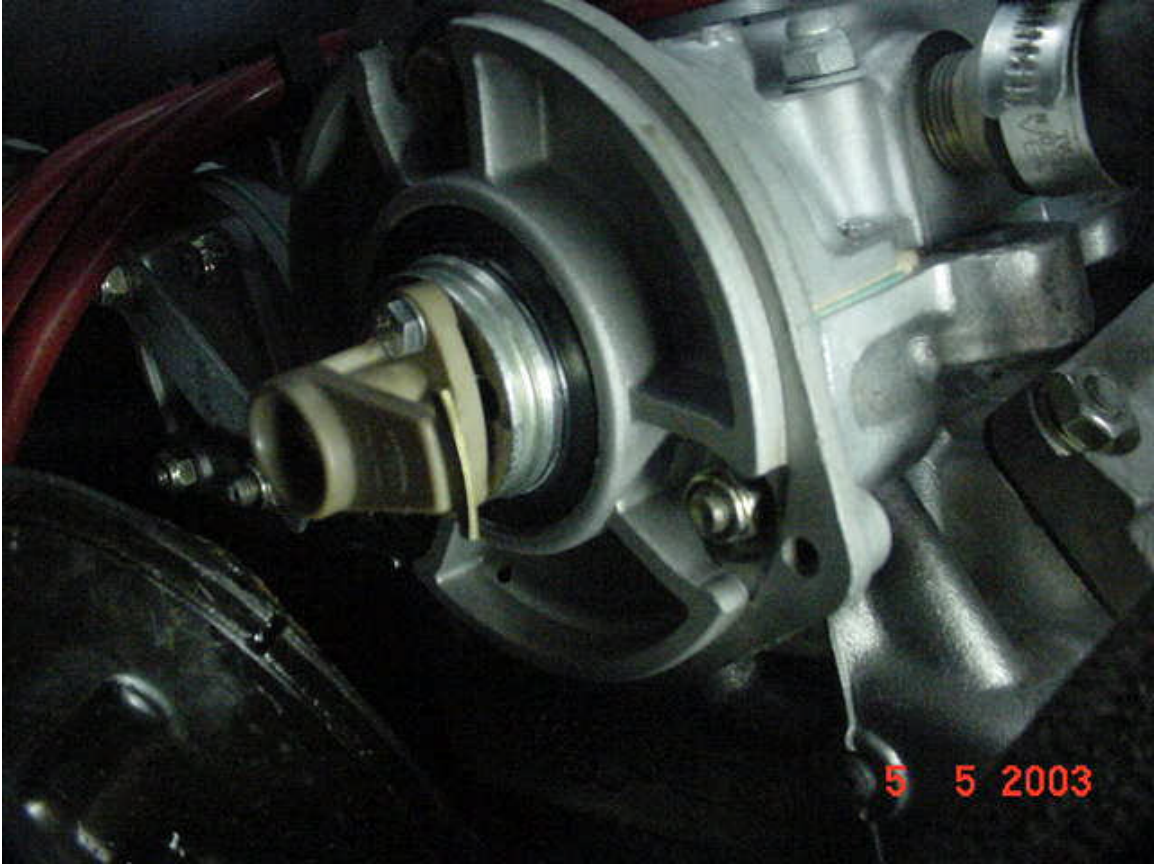
My cork cap gasket had disintegrated & was removed in pieces (new one in picture). Note the orientation of the rotor – you’ll need to reinstall as same. Rotor is held on by three 7mm screws; design doesn’t permit a socket to be used. I found a 7mm open-end wrench (part of the Craftsman metric “ignition wrenches” set) fit best. Each screw has a small washer underneath so be careful when removing. I brushed the rotor on my bench wire wheel and used a Dremel wire wheel attachment to clean the internal distributor cap posts.

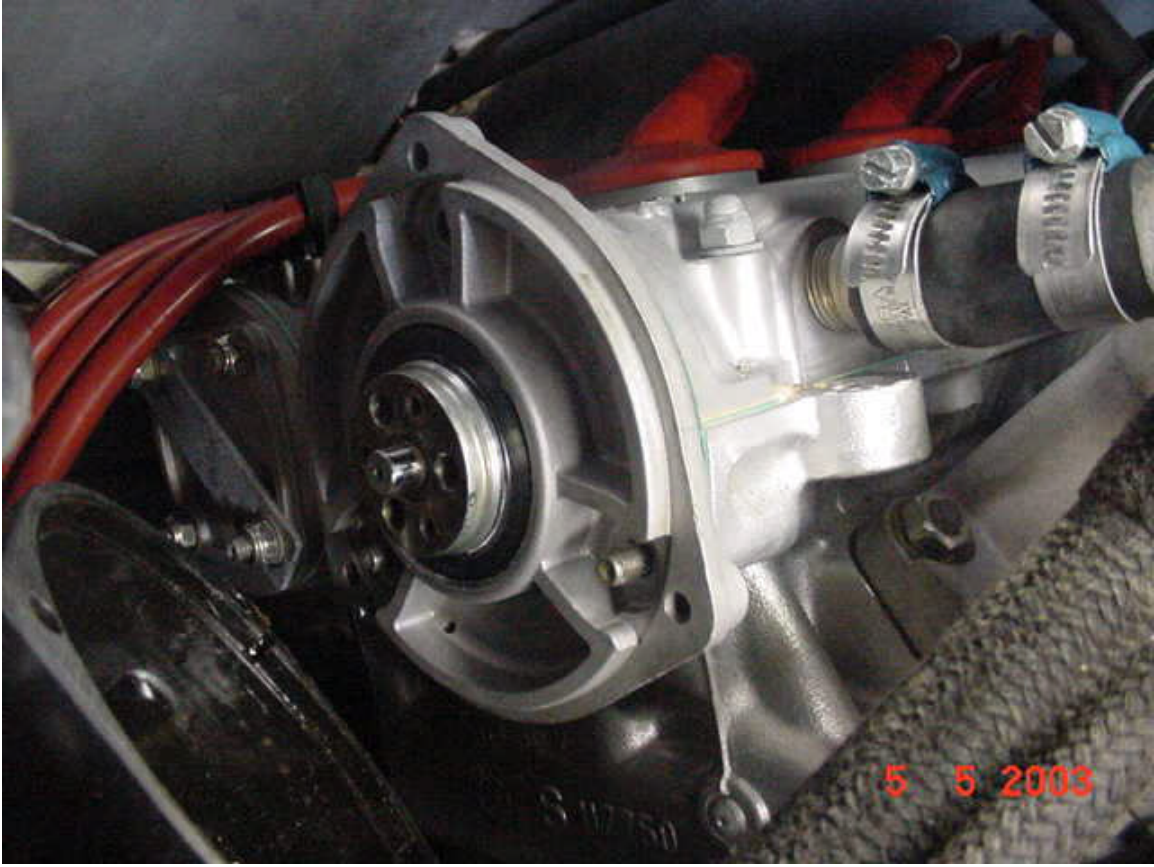
Oil was leaking into the distributor cap and a small amount had collected in the lower aspect of the distributor flange. The flange is held in place by two nylon-locking nuts on studs (2 & 6 o'clock) and one bolt (10 o'clock). Remove with short 10mm socket. Bolt had two washers underneath – solid & wave – and each nut had a small solid washer. Be careful not to drop these – I gently coaxed them off the stud with small flat screwdriver. At this point I tapped the flange with the back of my hand and it came free.

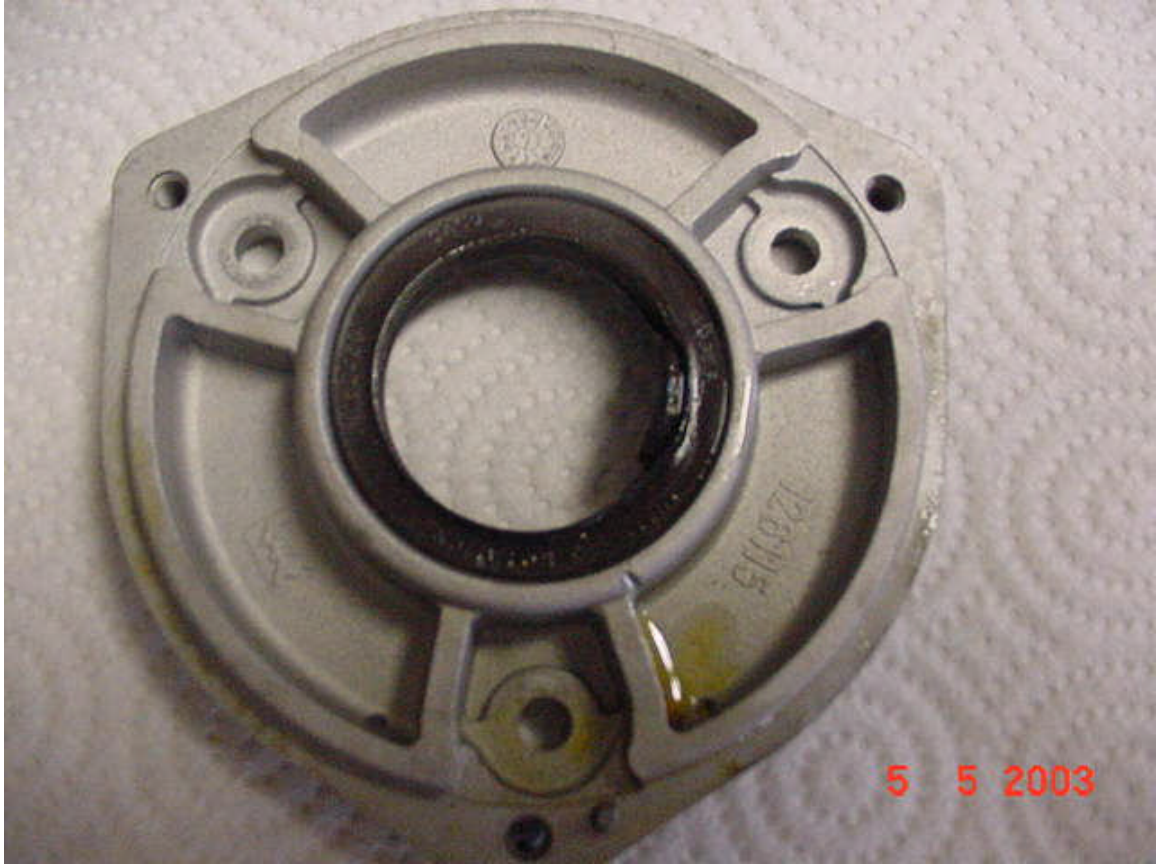
Etiology of oil leak was immediately obvious – seal had been damaged installing on shaft (at 3 o'clock in photo):

Press the old seal out in the vise using a 32mm 1/2" drive socket and two pieces of wood to support the flange:

Lubricate the outer perimeter of the new seal with WD-40 and press it squarely into flange:

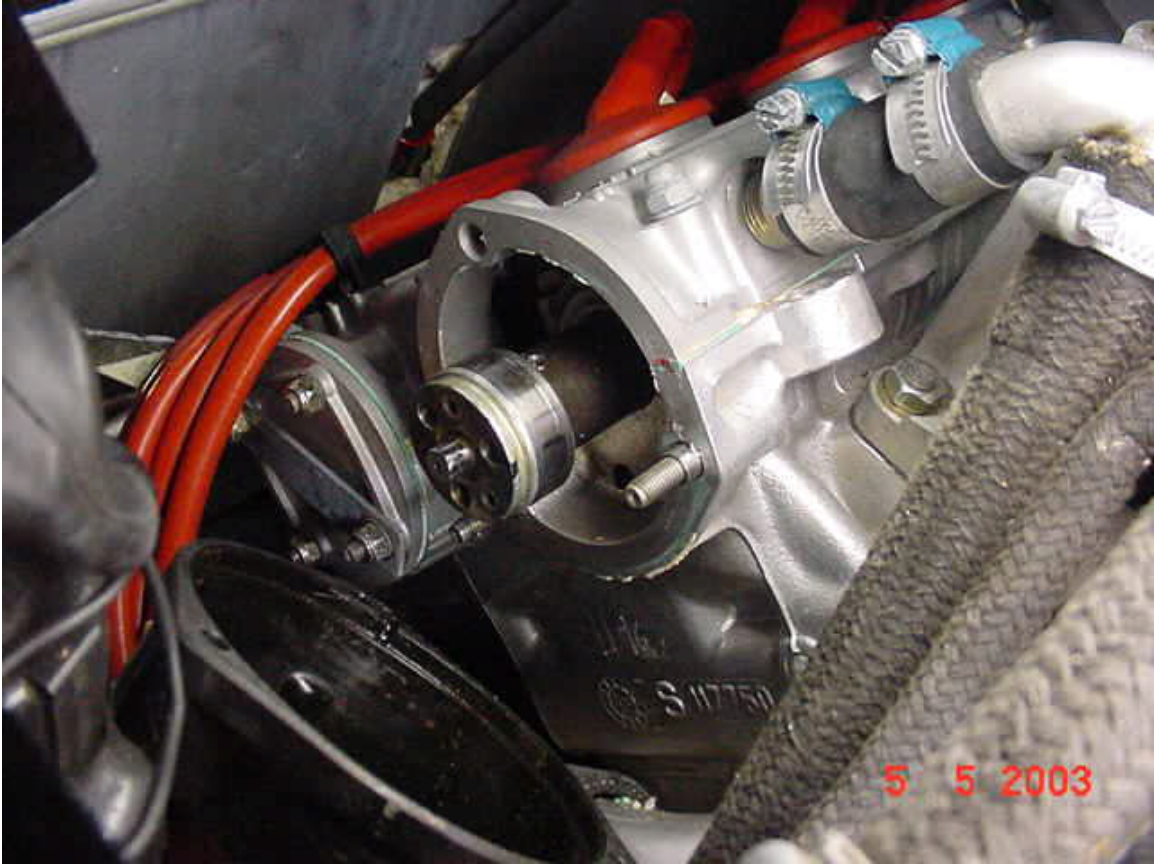
The flange mounting gasket peeled off the valve cover without leaving much residue behind. I cleaned this area and mounting face of flange then wiped with alcohol.

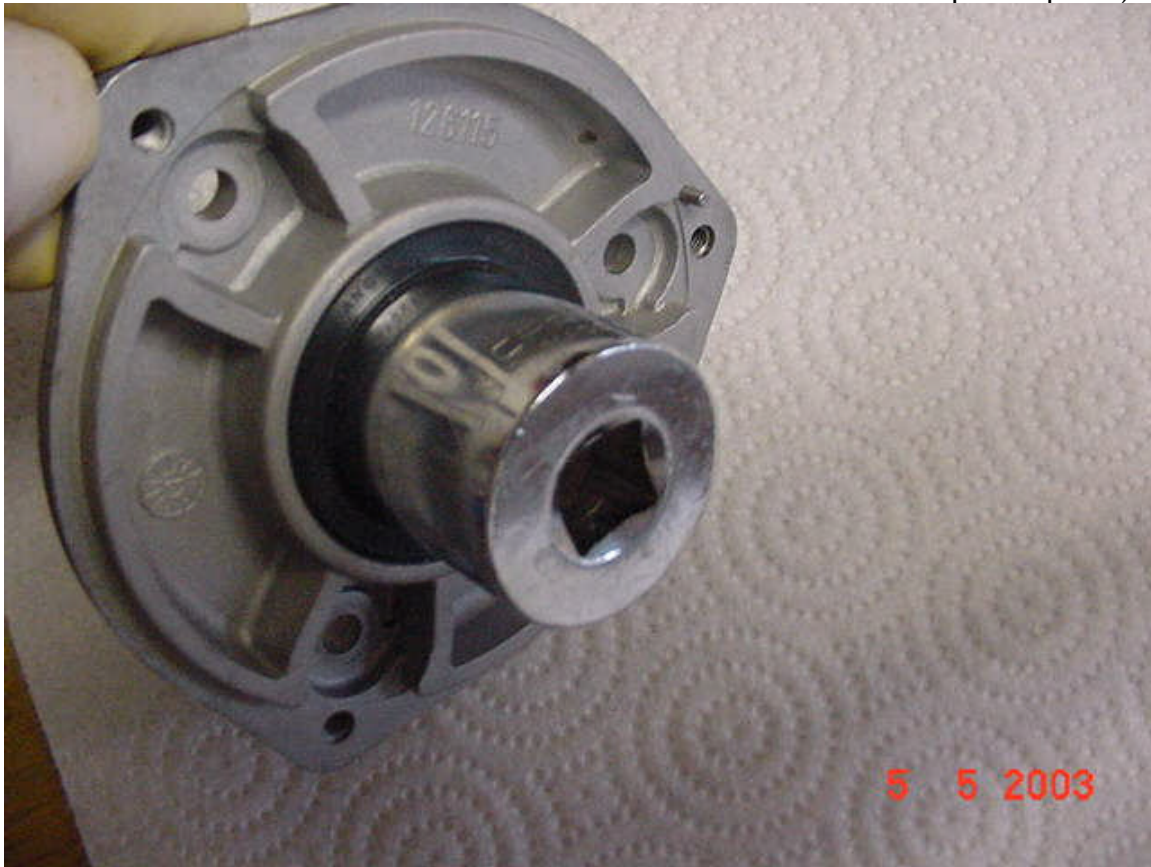
I lubricated the inner rim of the seal with oil and wiped oil and a smear of white lithium on the distributor shaft. I then found a 1 1/16 1/2" Craftsman drive socket most closely approximated the shaft diameter; using this as a "guide arbor" during installation helps keep flange perpendicular to shaft and stretches the circular spring inside the seal, making it less likely to pop free (I understand there is a specific Ferrari tool just for this particular

seal installation but to date have not been able to locate an illustration or specific part #):

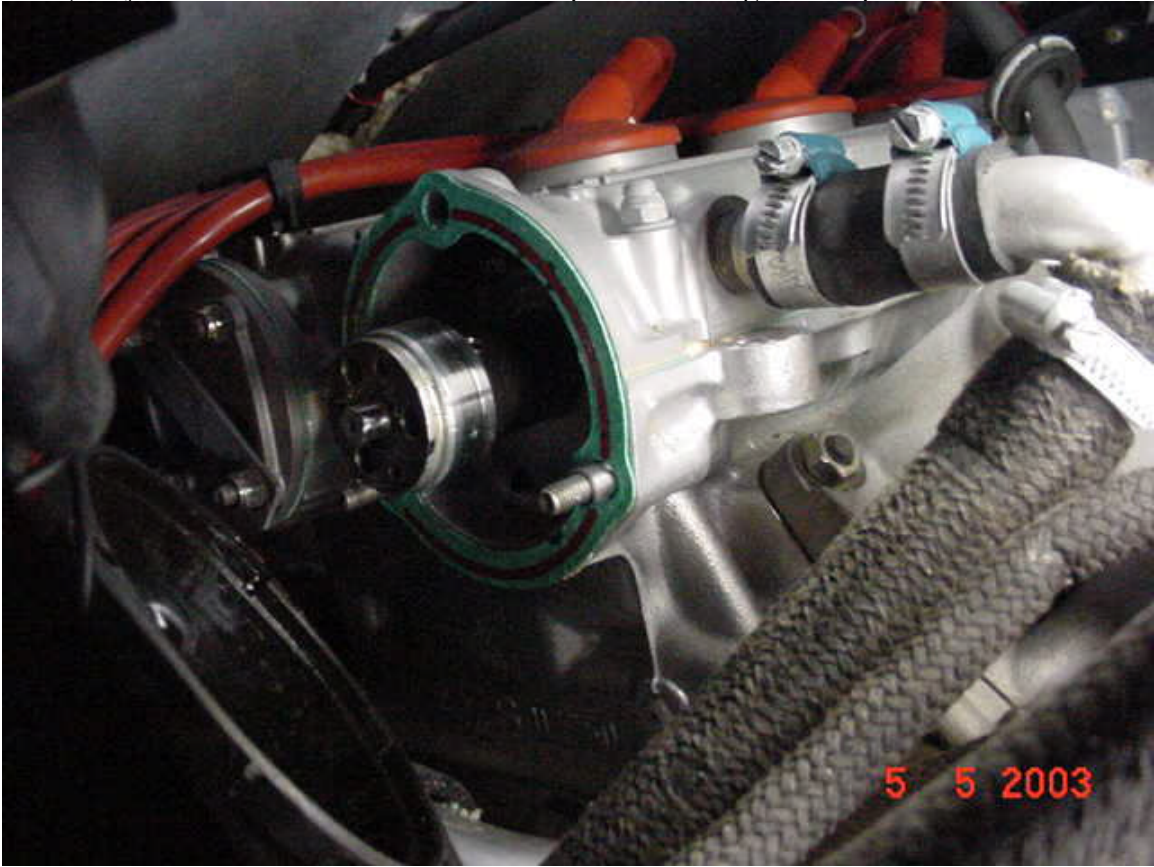
Coat both sides of the mounting flange gasket with a very thin coat of clear silicon then install. Note the gasket is asymmetric – the two larger holes fit over the studs while the smaller is for the bolt. Take care not to dislodge either of the two smooth “collars” on the

studs; they slide off and can be lost in the depths of the engine compartment.

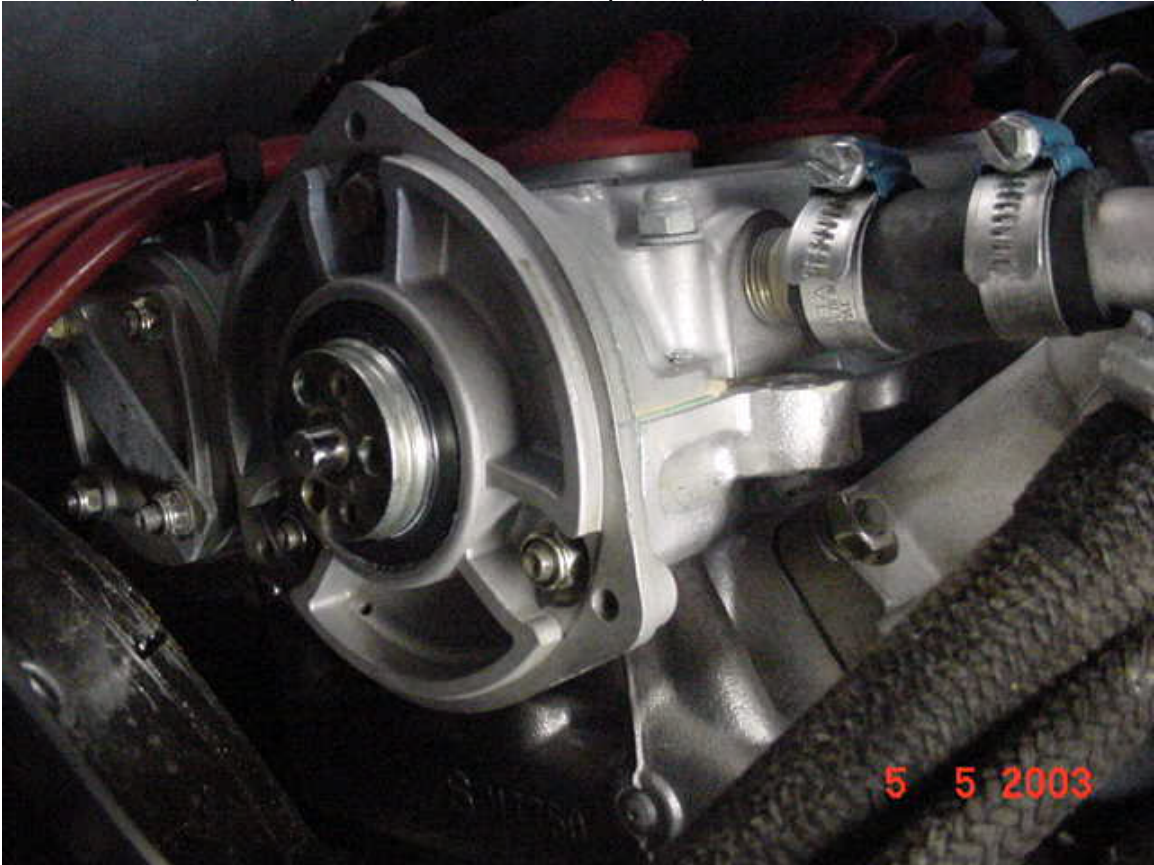
Install the distributor flange, centering the socket on the shaft (didn't have third hand to take a picture of this!). The flange should go down straight. Install the nylon nuts and bolt and tighten gently in sequence. Inspect the circumference of the seal to ensure it hasn't

been distorted (use inspection mirror for lower portion).

Remainder is reverse of disassembly. Fit a new distributor cap cork gasket. Inside of rubber boot can be lubricated with Armor-All if difficult to slide on. Run/drive the car and remove the cap in a few weeks to confirm leak repaired.
