## **Ferrari 328 Heater Core Removal & Repair**

*Carl Rose  
March 2003*

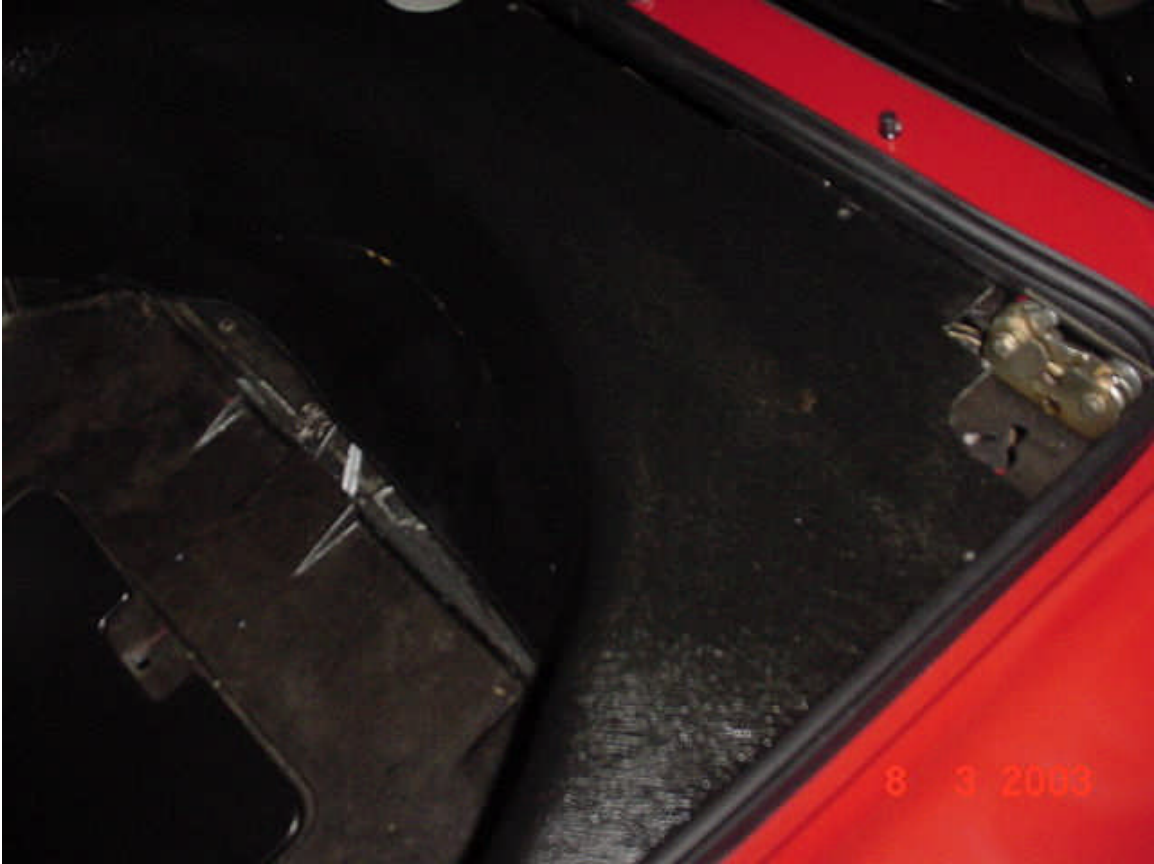
First open the front hood & put soft towels down to protect each fender. Remove spare wheel/tools & set aside. The upper fiberglass cowl cover is held in place by small black Phillips screws. Two longer screws & flat washers attach front lower corners to inner fender well. Carefully lift panel off (corners are brittle & chip easily):

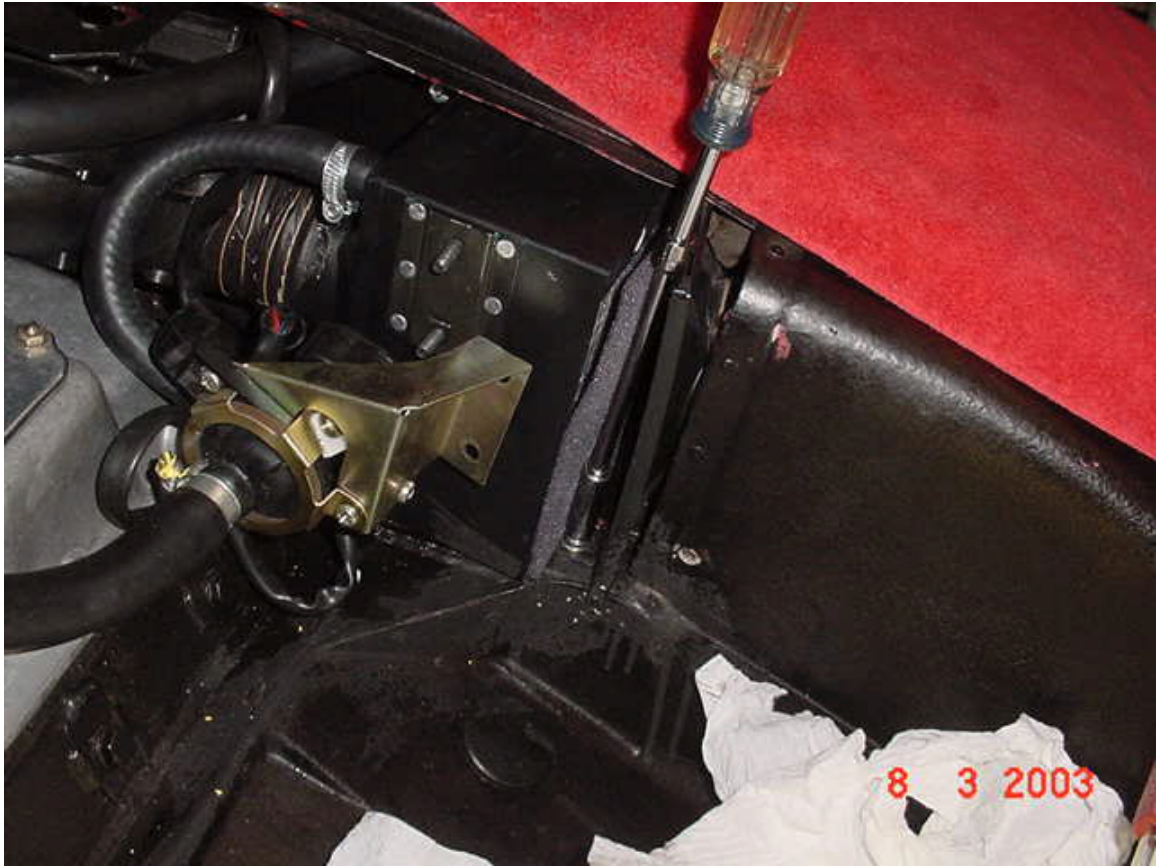
The heater cores are located in the square black boxes on either side. Remove the small 10mm cad-plated nut holding the lower inner corner of the box (wiggle heater core to relieve pressure of bracket on threads & readily unscrews with fingers):

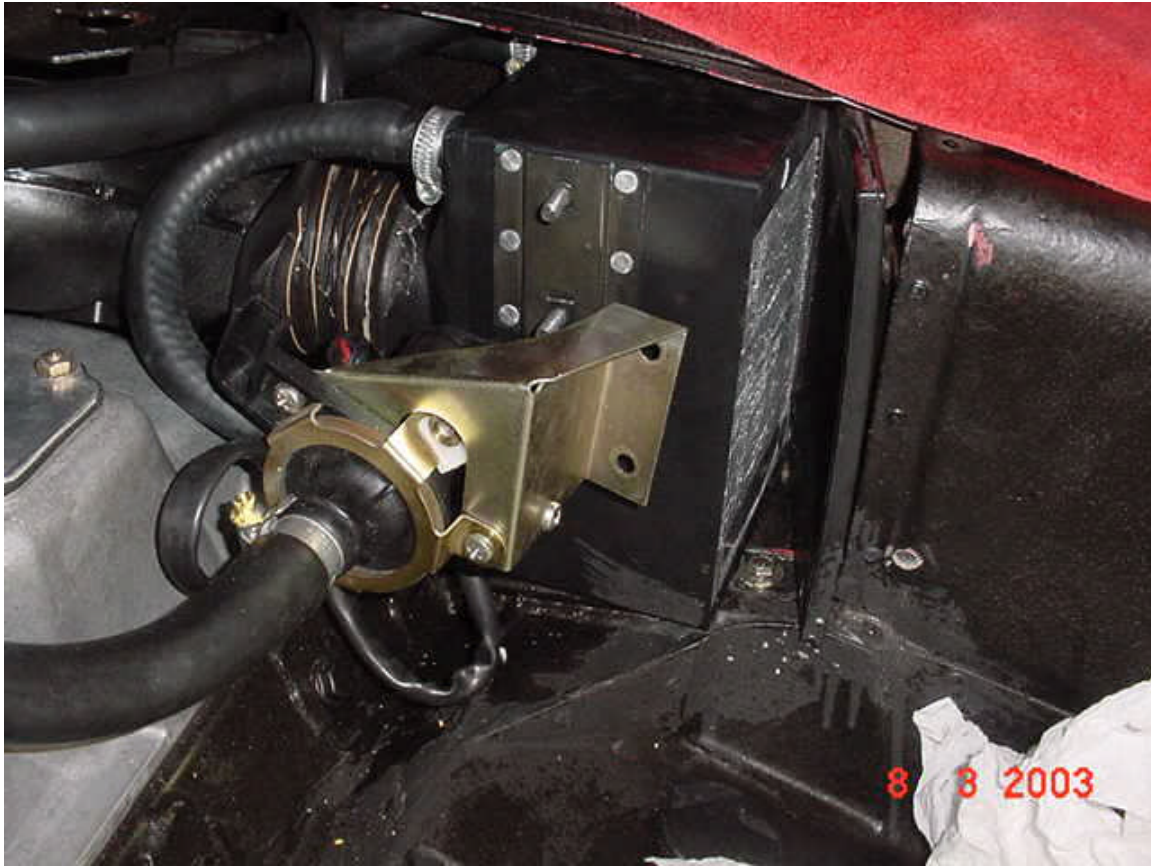
Remove heater control valve bracket nuts from medially side studs on box. Without disengaging from fabric inlet hose from fender, push “cover” towards front of car to separate from box. A thin grey foam filter (visible in previous picture) protects core, but may have disintegrated. Put towels in spare tire well. I clamped a Vise-Grip (with tape over jaws) to compress hose from heater valve before disconnecting (thus spill minimal coolant). Undo hose clamp with 7mm socket driver and gently disengage from inflow tube. Remember antifreeze can mar paint.

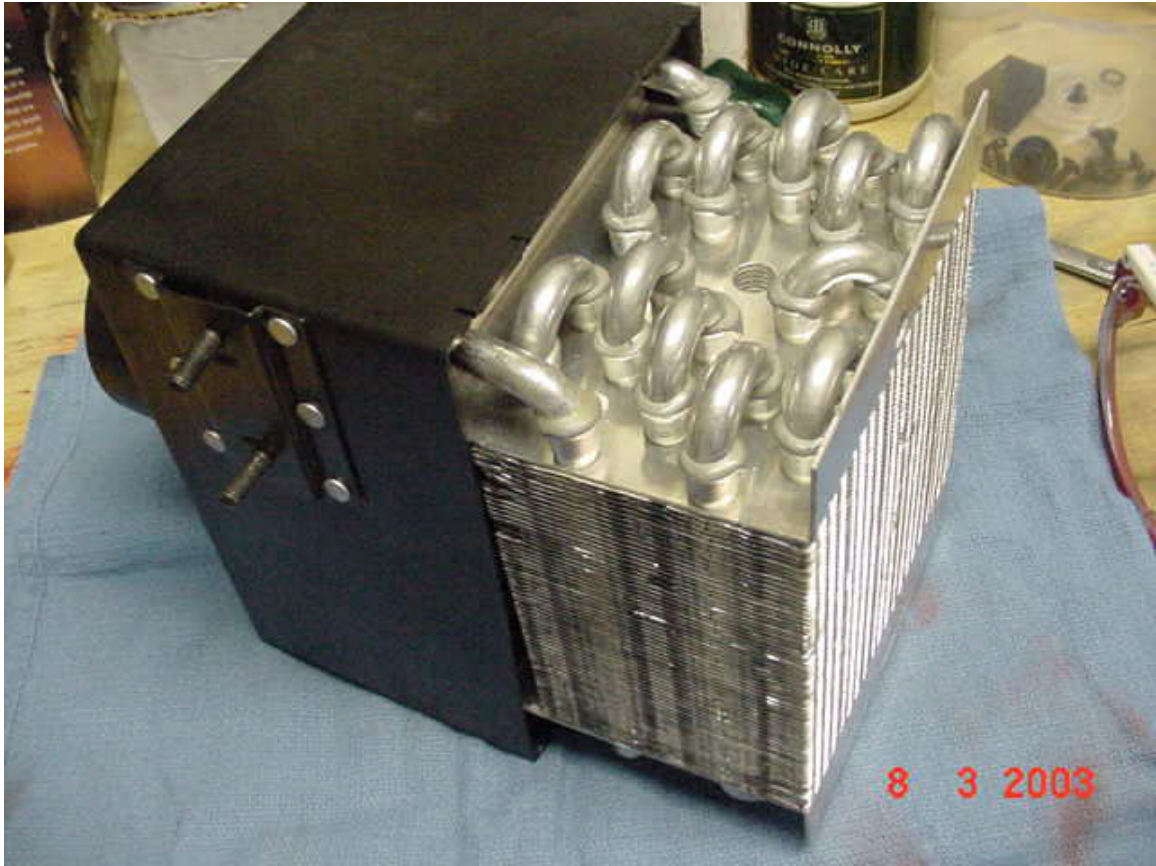
The heater core is delicate aluminum and as such be gentle extracting from plastic heater box:

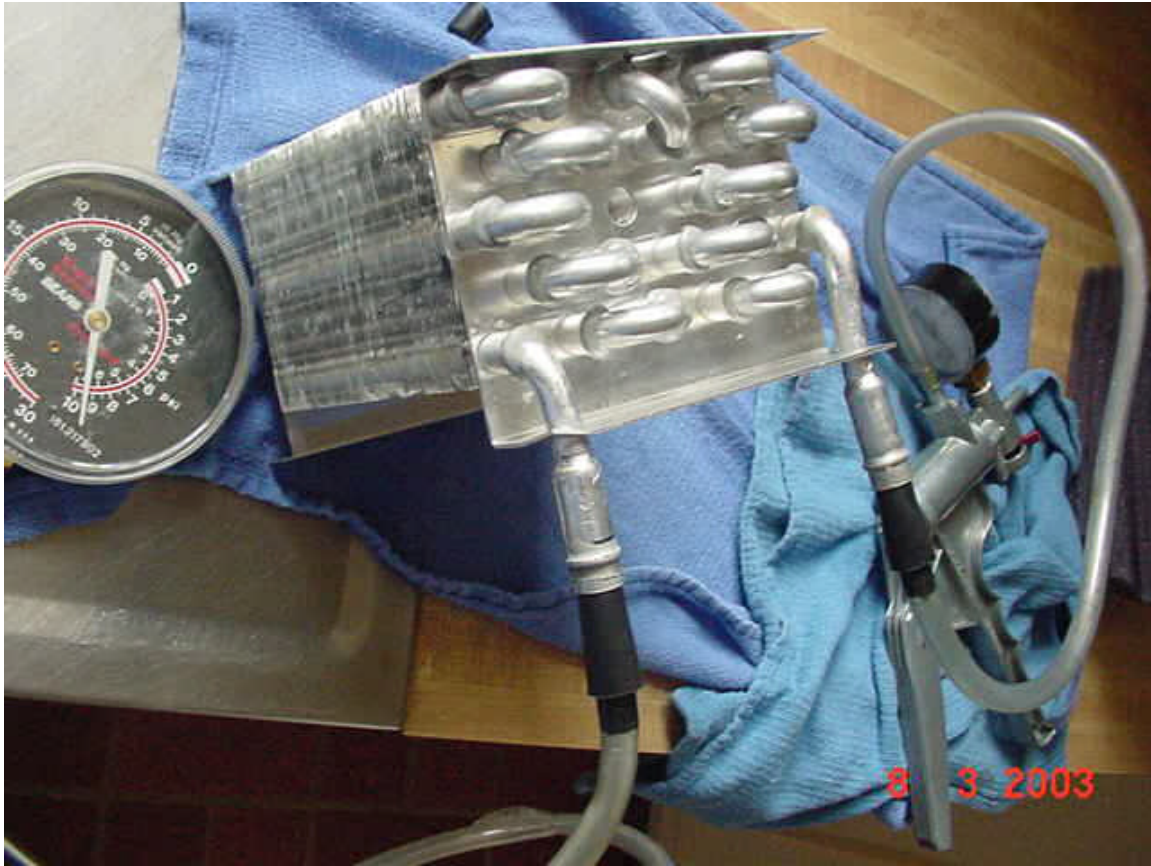
Both inflow/outflow tubes & upper recirculation tubes are glued in place with epoxy. I used a Mity-Vac pump top pressurize outflow to 9-10 psi and attached vaccum gauge to inflow:

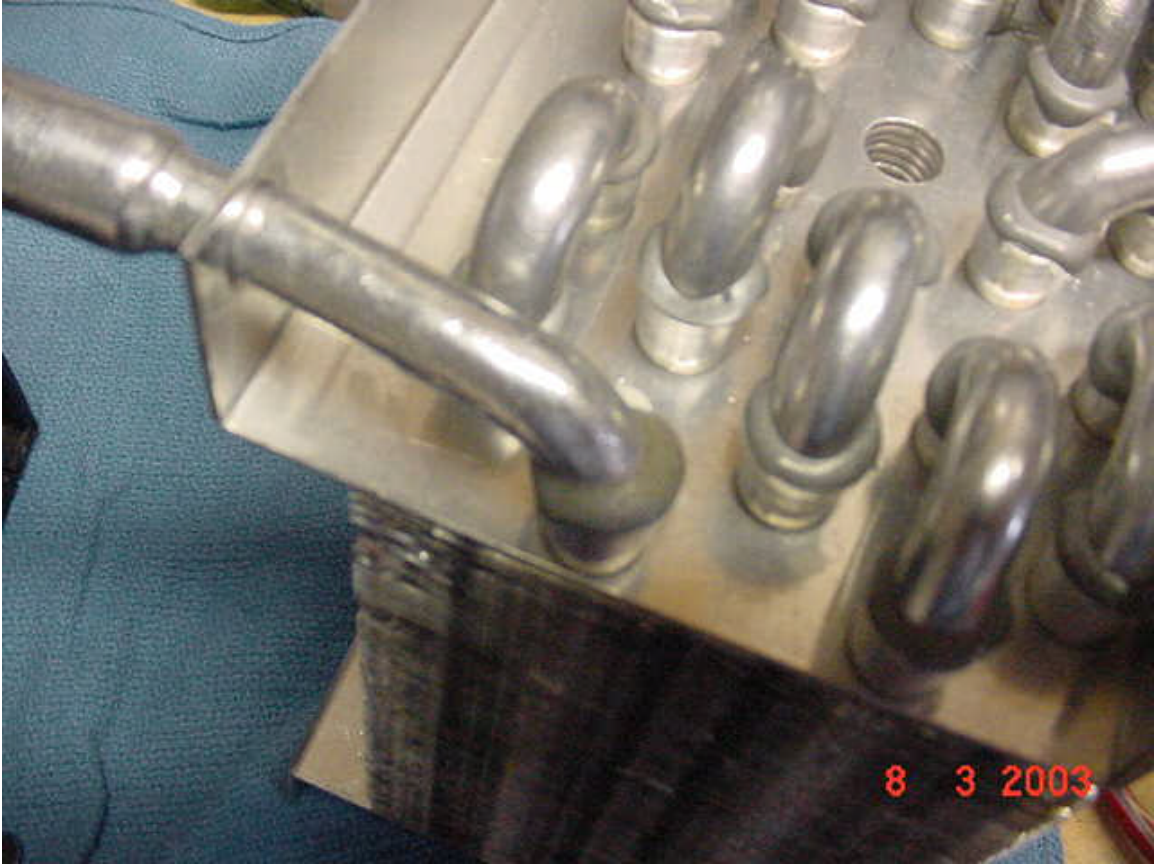
My core was initially intact but process of removal loosened the inflow tube (discovered by submerging in large pan of water). As the tube was only slightly loose & I wasn't sure how to remove epoxy without damaging aluminum core tubing (partially successful heating with soldering iron), I ran a bead of superglue around the tubing perimeter & let dry for 30min. Reinforcing with JB weld might also be a good choice (something similar appears to have been used in initial assembly).

Re-pressurization confirmed core was airtight. I also ran water through until outflow was clear.

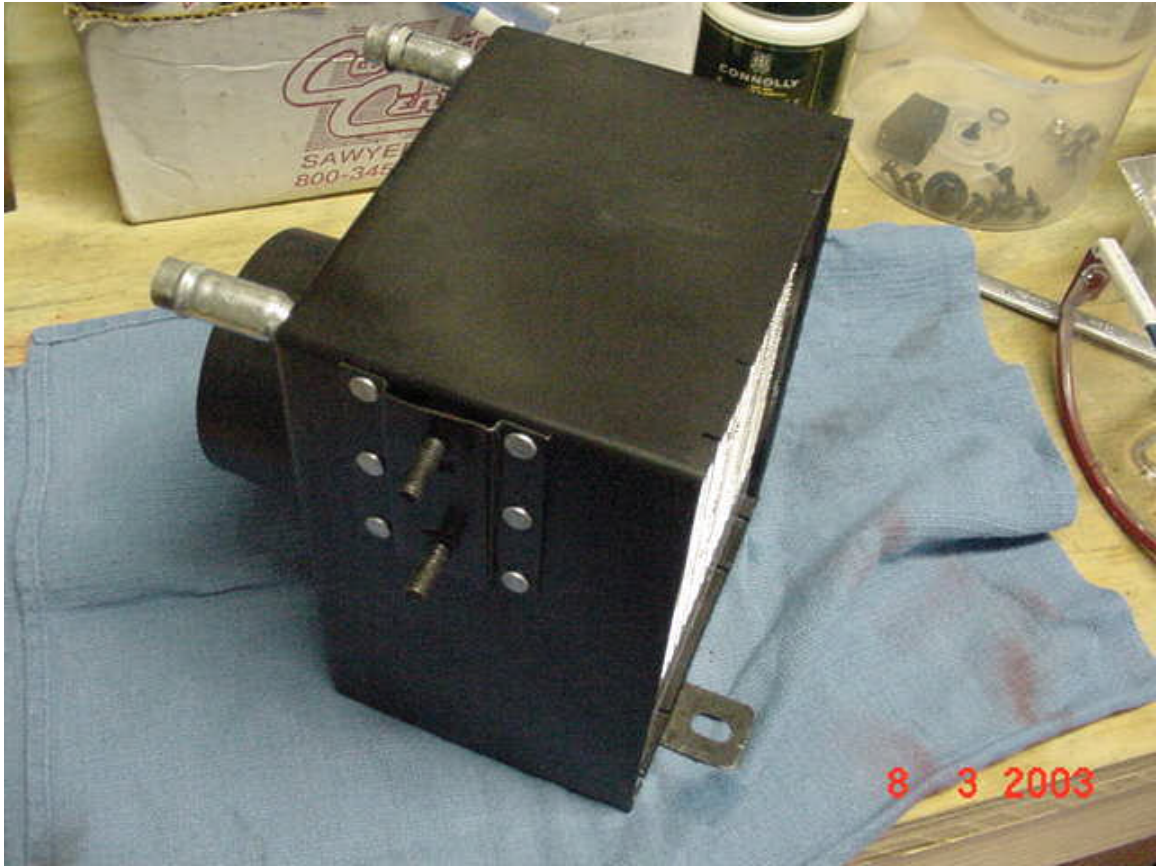
Carefully replace core into heater box. I purchased new 1/4" grey foam material from Grainger; dimensions are 6.5"x5" but unfortunately had to purchase 25ft roll – more than I'll ever need – drop me an email: [carlrosemd@hotmail.com](mailto:carlrosemd@hotmail.com) be happy to send you a set.

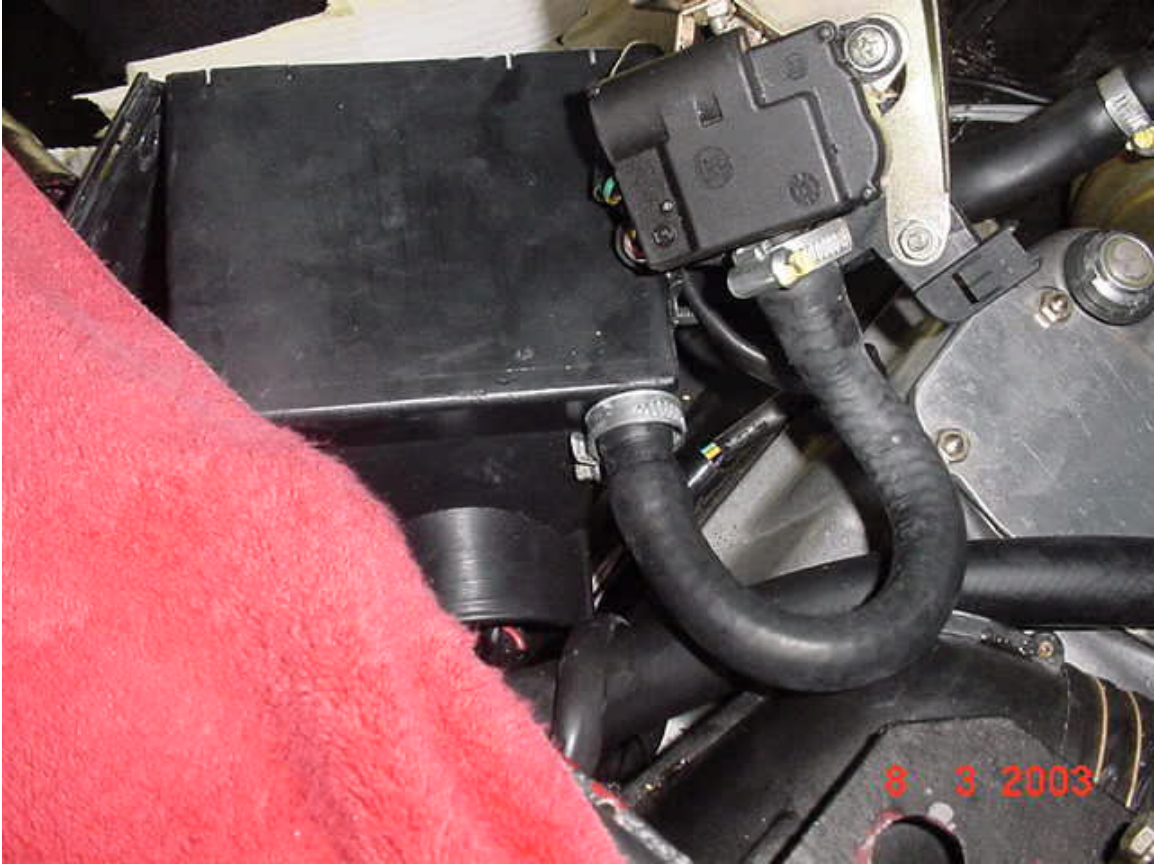
Replacement is essentially reverse of removal. I connected the outer outflow hose then used the Mity-Vac to essentially “vacuum” the coolant back through the core to expedite subsequently bleeding cooling system. Removed pump, rapidly put my finger over the tubing, then re-connected hose to heater valve.

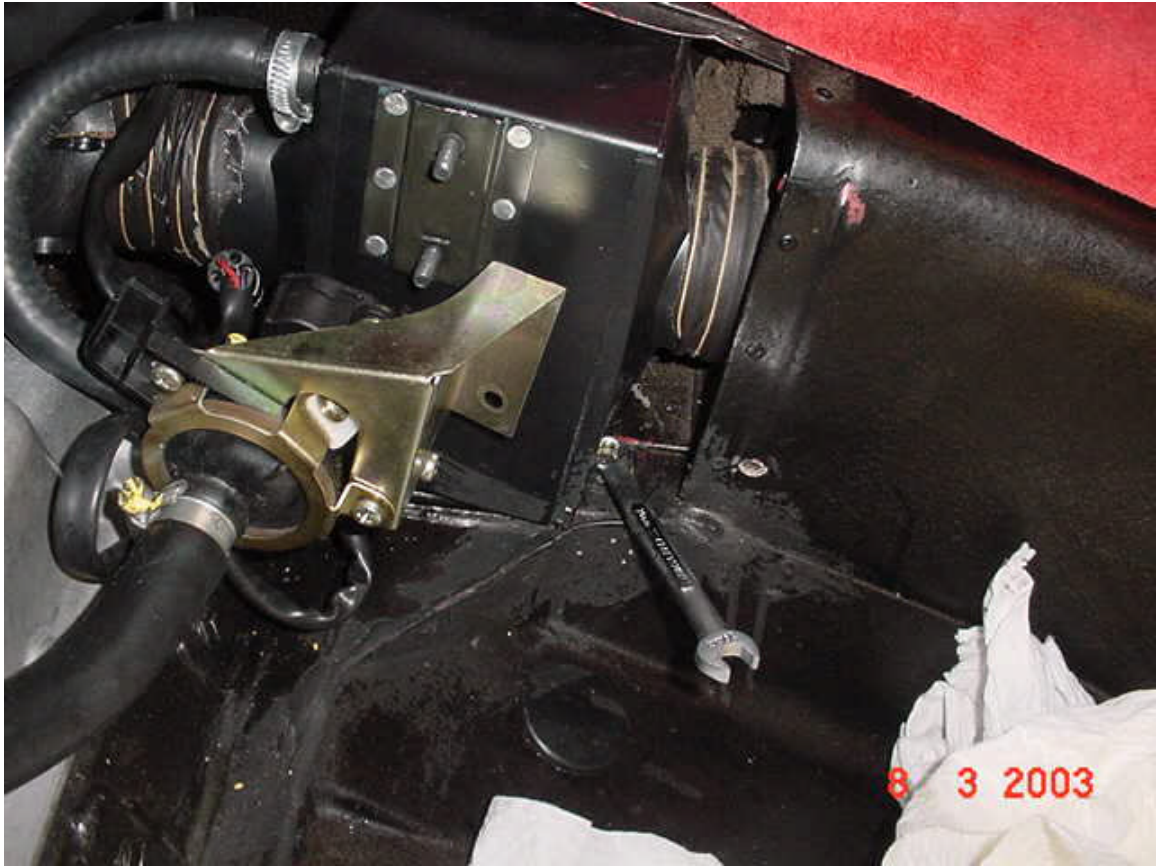
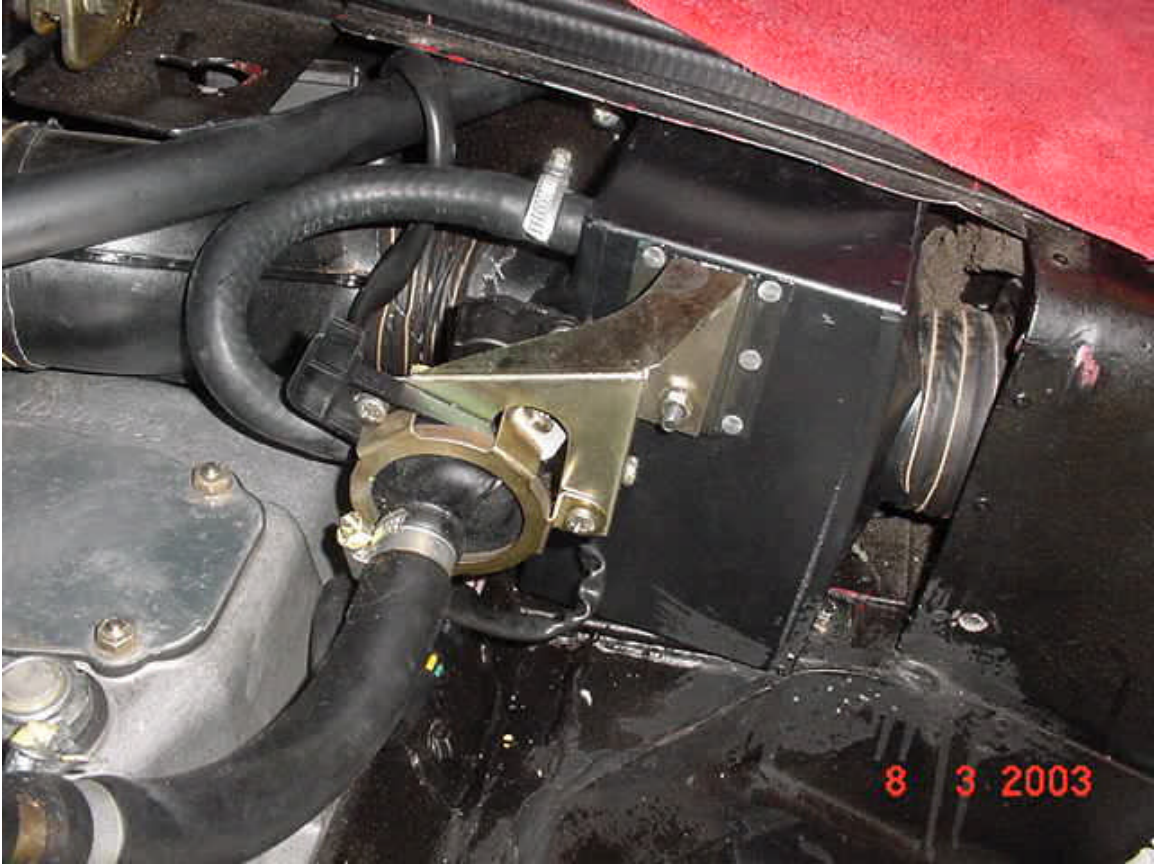
Tighten clamps then wiggle back into place. I also found it easier to assemble the “front” to the heater box prior to re-attaching to body with 10mm bolt. The cockpit duct bellows hose can also prove a challenge to reinstall.
