RECALL CAMPAIGN NO. 143

FLEXIBLE OIL LINES FOR
ENGINE OIL RADIATOR

RECALL CAMPAIGN NO. 144

FLEXIBLE RUBBER HOSE FOR FUEL RETURN

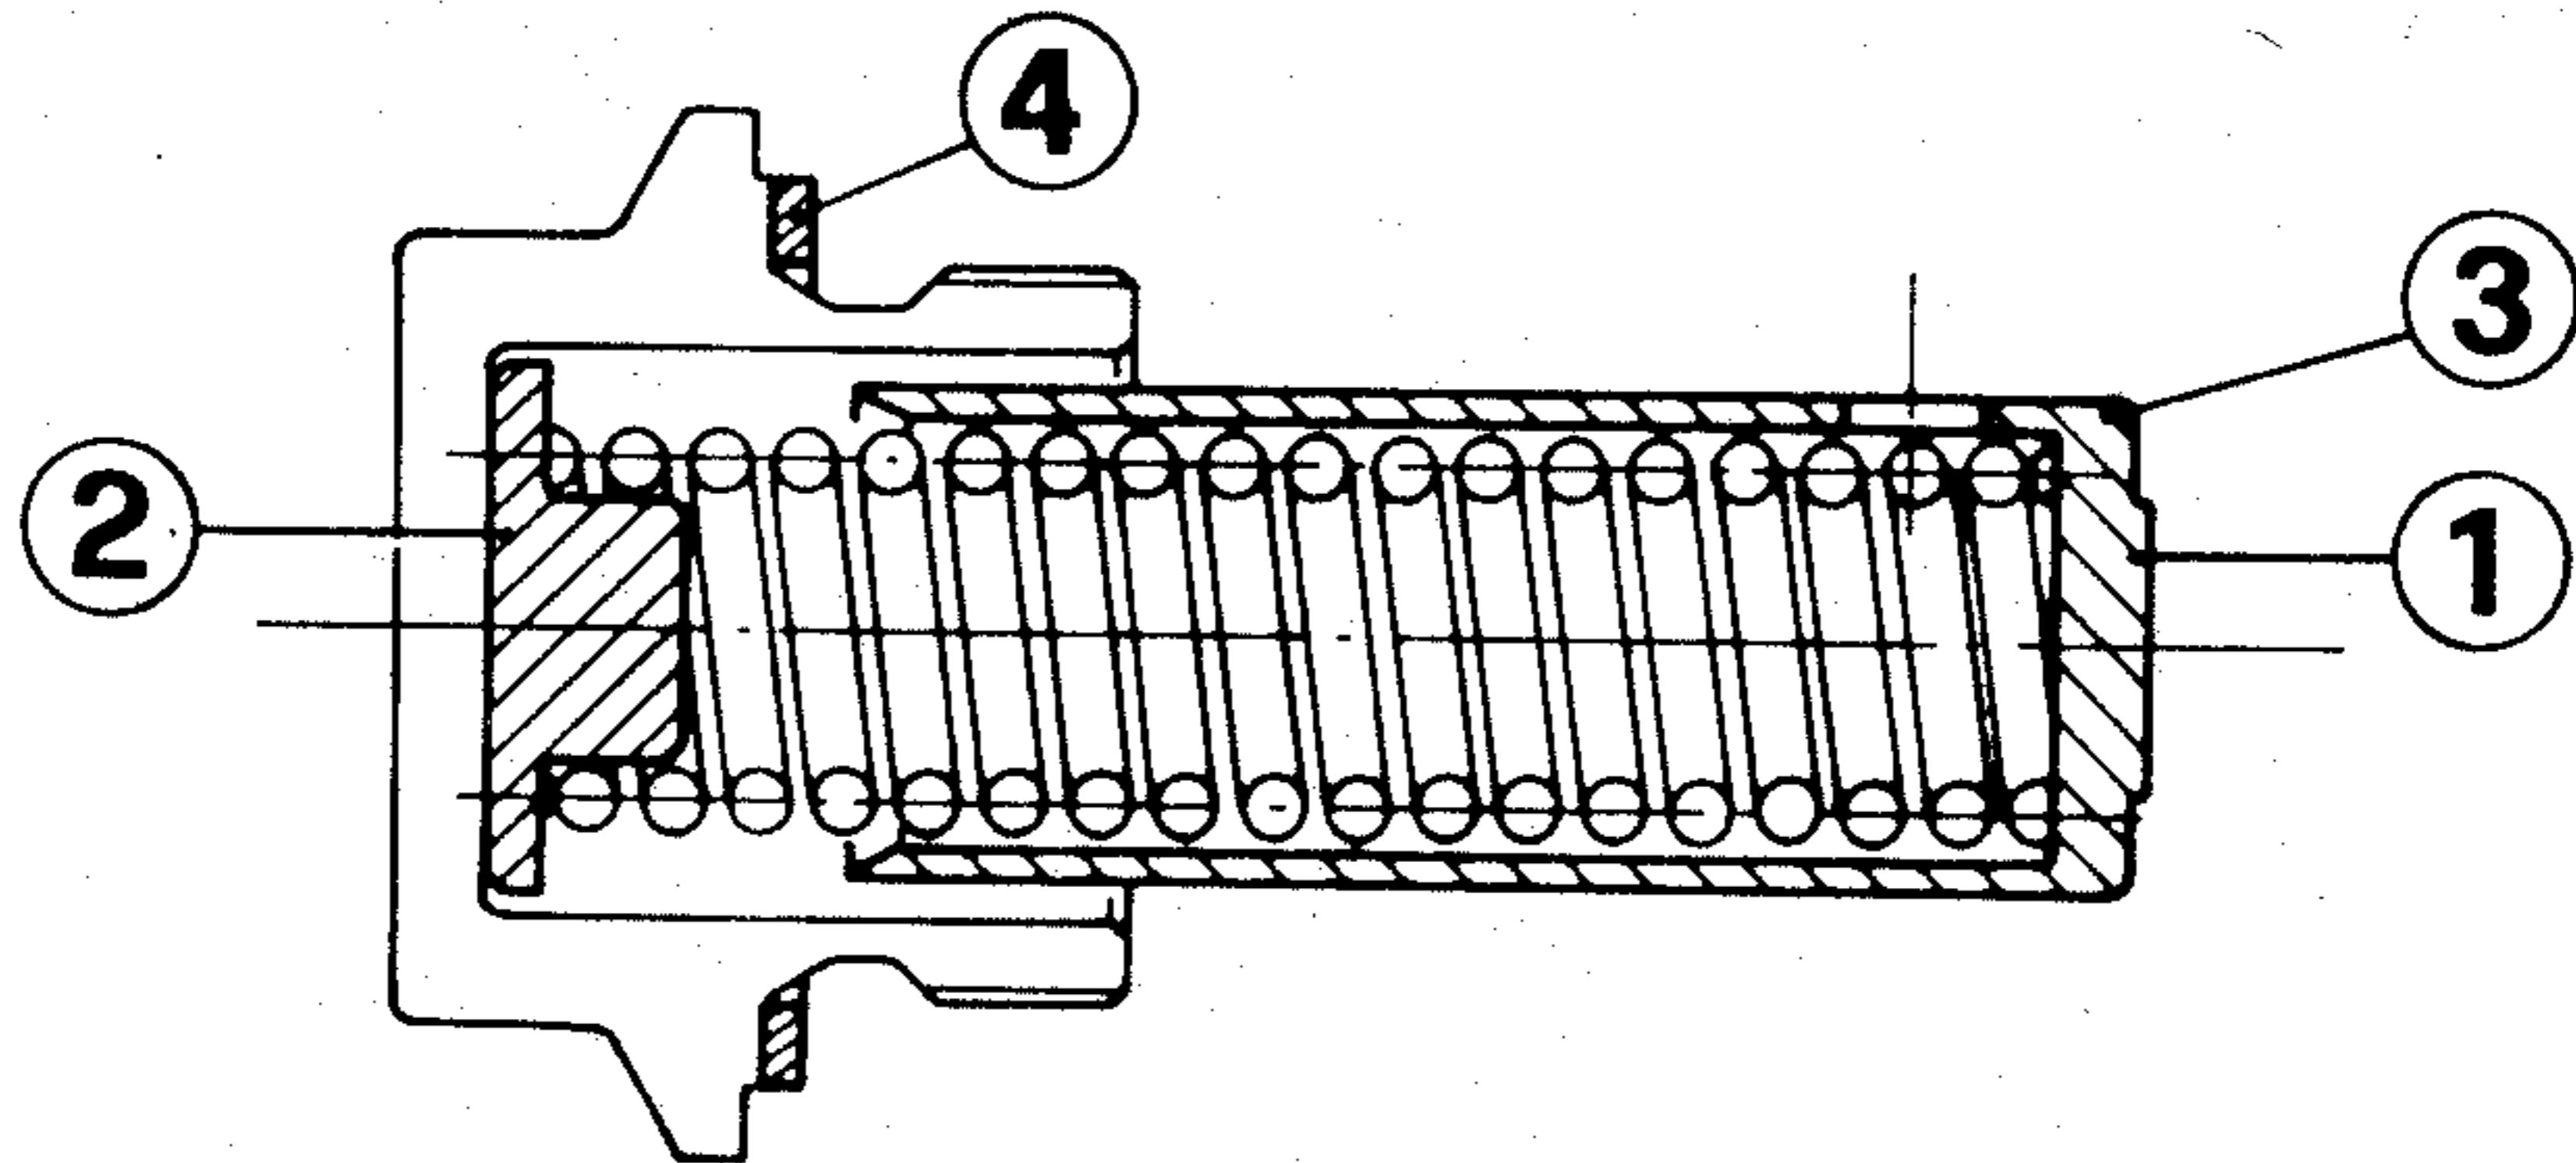
Fig. 3

- 1 - With a 32mm wrench, unscrew and remove the cap 1, Fig.2.
- 2 - Remove the spring 2, Fig. 2, and remove the existing control plunger 3, Fig. 2.
- 3 - Remove the spacer 4, Fig. 2 for the spring.
- 4 - Insert the new control plunger 1, Fig. 3, which has the 3 new lateral holes 3, Fig. 3, and check that it slides freely into the sleeve.

- 5 - Insert the new spacer 2, Fig. 3, and verify that the centering portion enters properly the spring as shown in Fig. 3.
- 6 - Reinstall the cap with the proper gasket.

IMPORTANT: After the updating is performed, please identify the cap with a green painted mark.

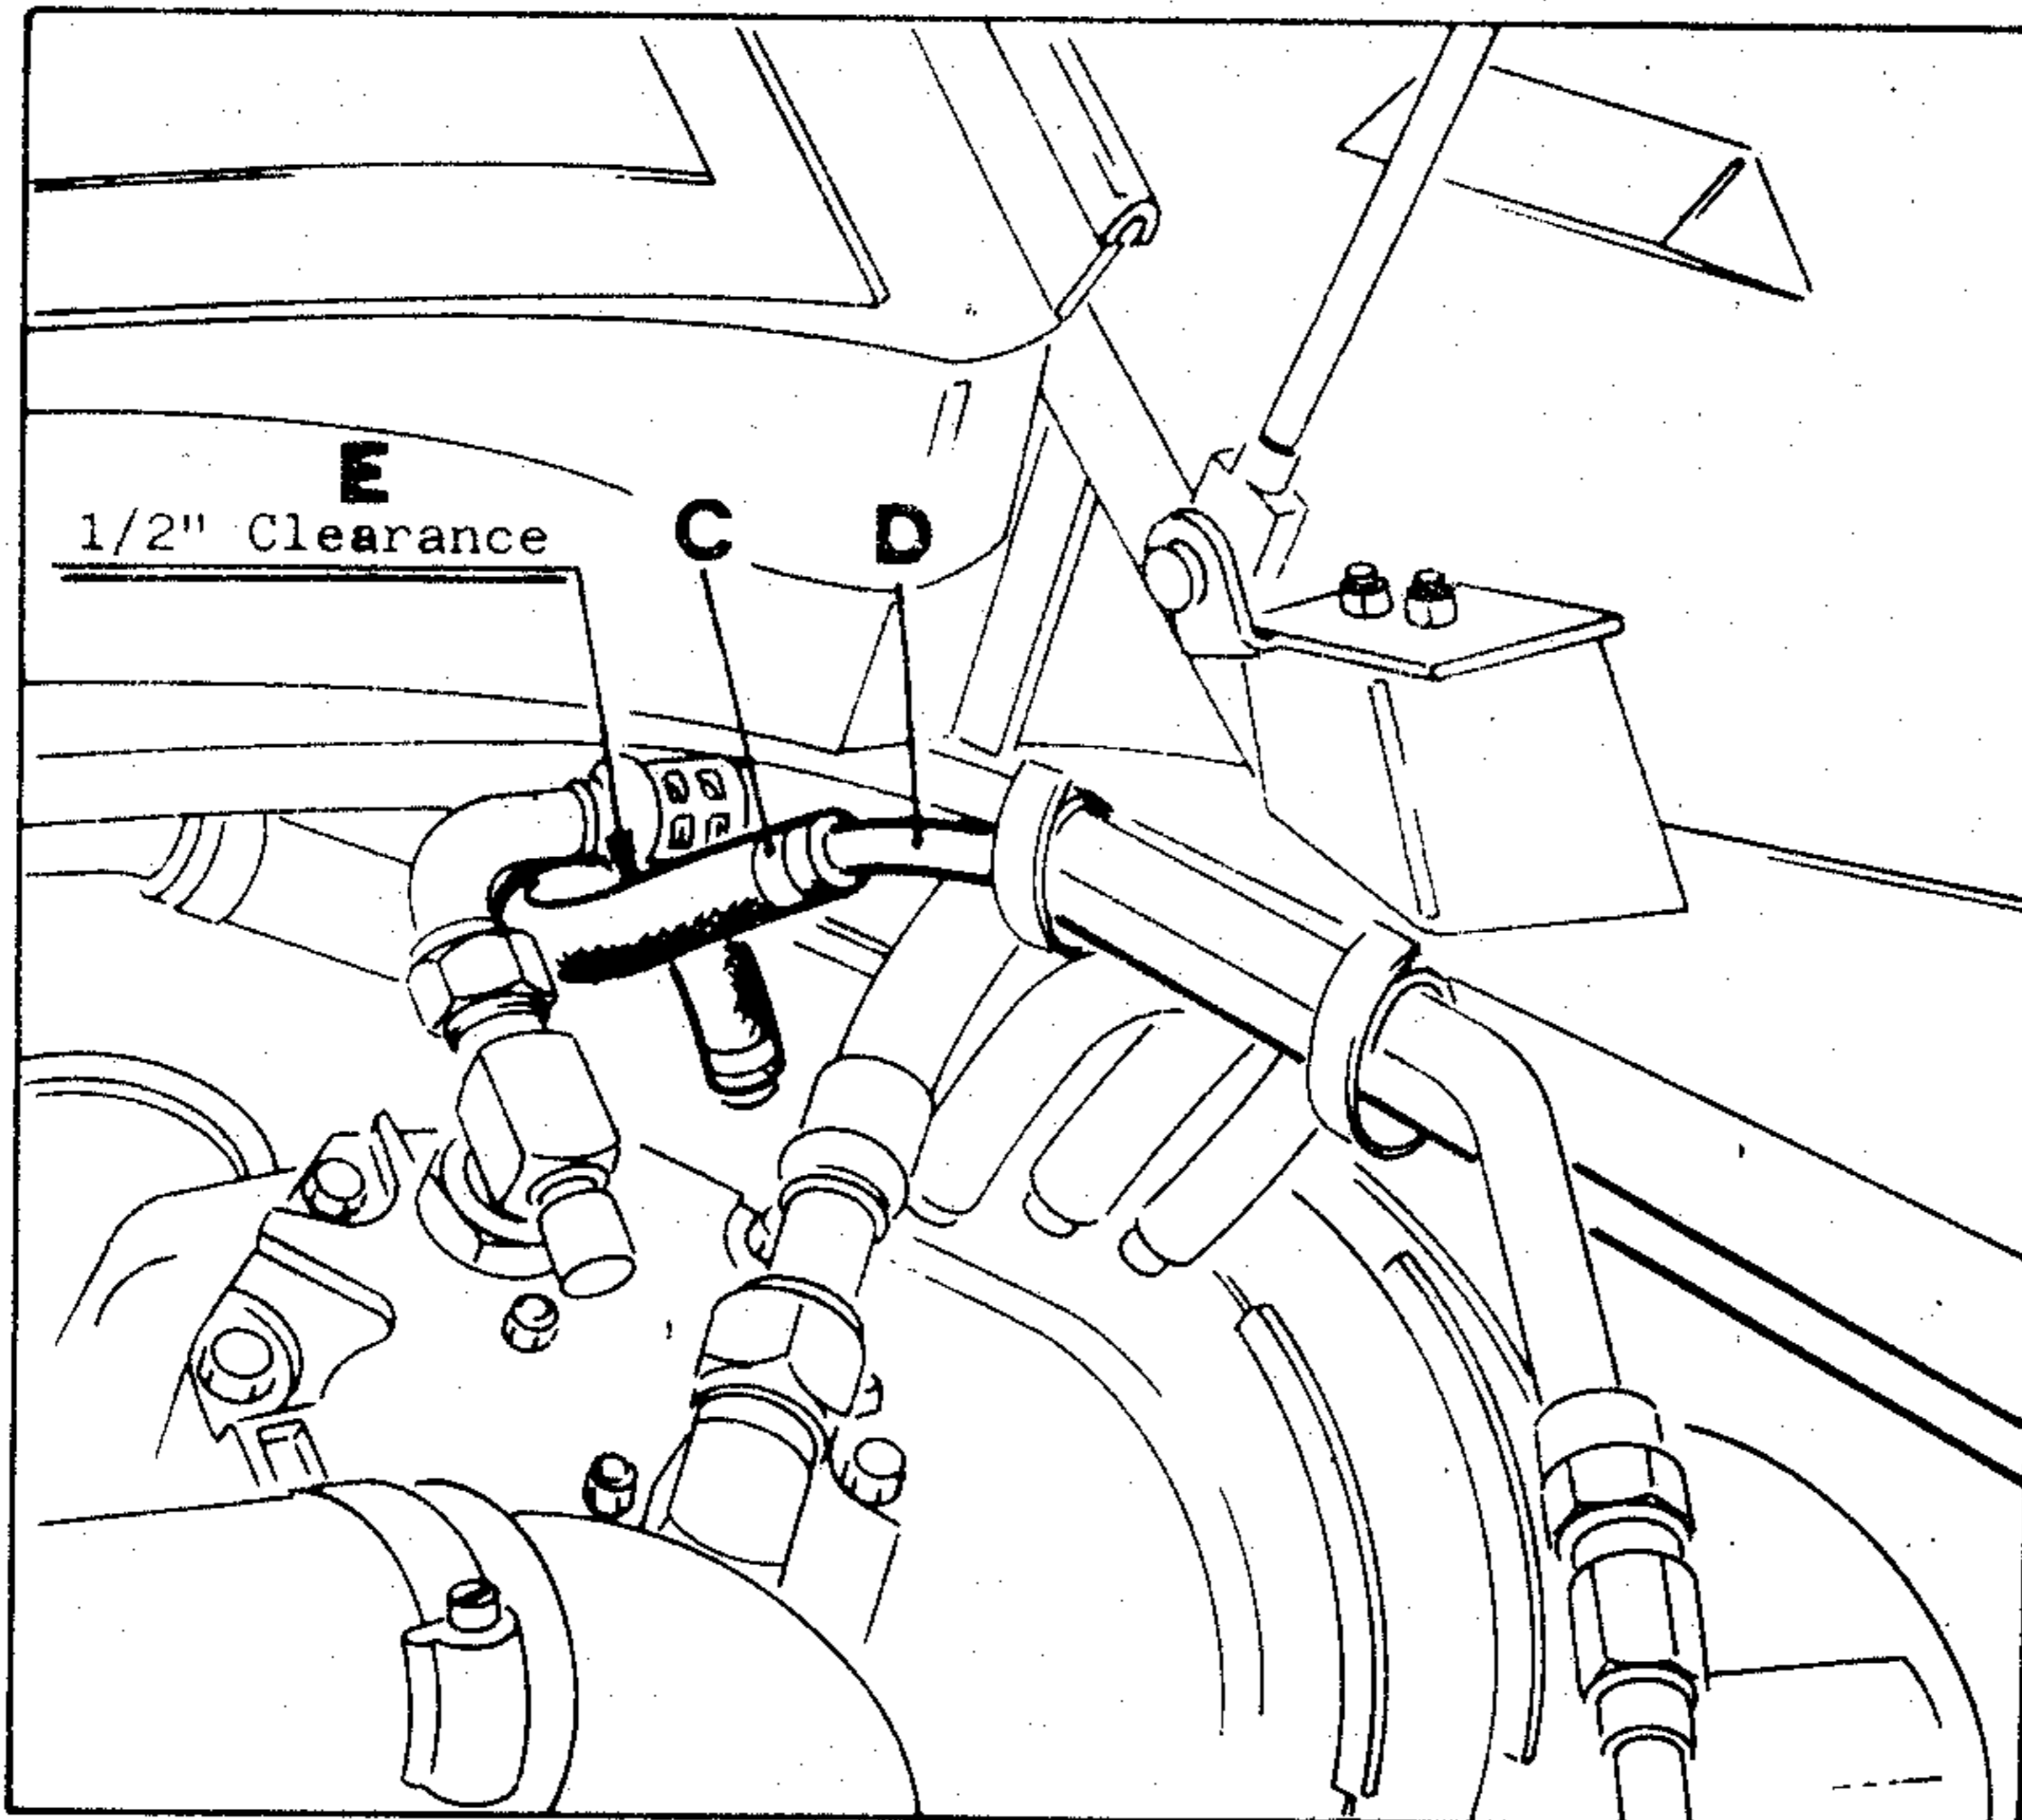
- 5 - Using a round rod as a lever, which must react on the frame member, push downwards on the clamp C, Fig. 2, in order to slightly re-shape the metallic pipe D, Fig. 2, and increase its downward curvature until the clearance E between the rubber hose and the connector of the air conditioner compressor becomes sufficient (approximately 1/2").

- 6 - Check that clamp C, Fig. 2 has remained properly tight.
- 7 - If the existing hose shows abrasion or damage, replace it with a new one, which shall be installed with 2 new clamps.
