DATE: 8/10/87

SUBJECT: CLUTCH RELEASE SYSTEM**VEHICLES: TURBO & 328 GTS / GTB**

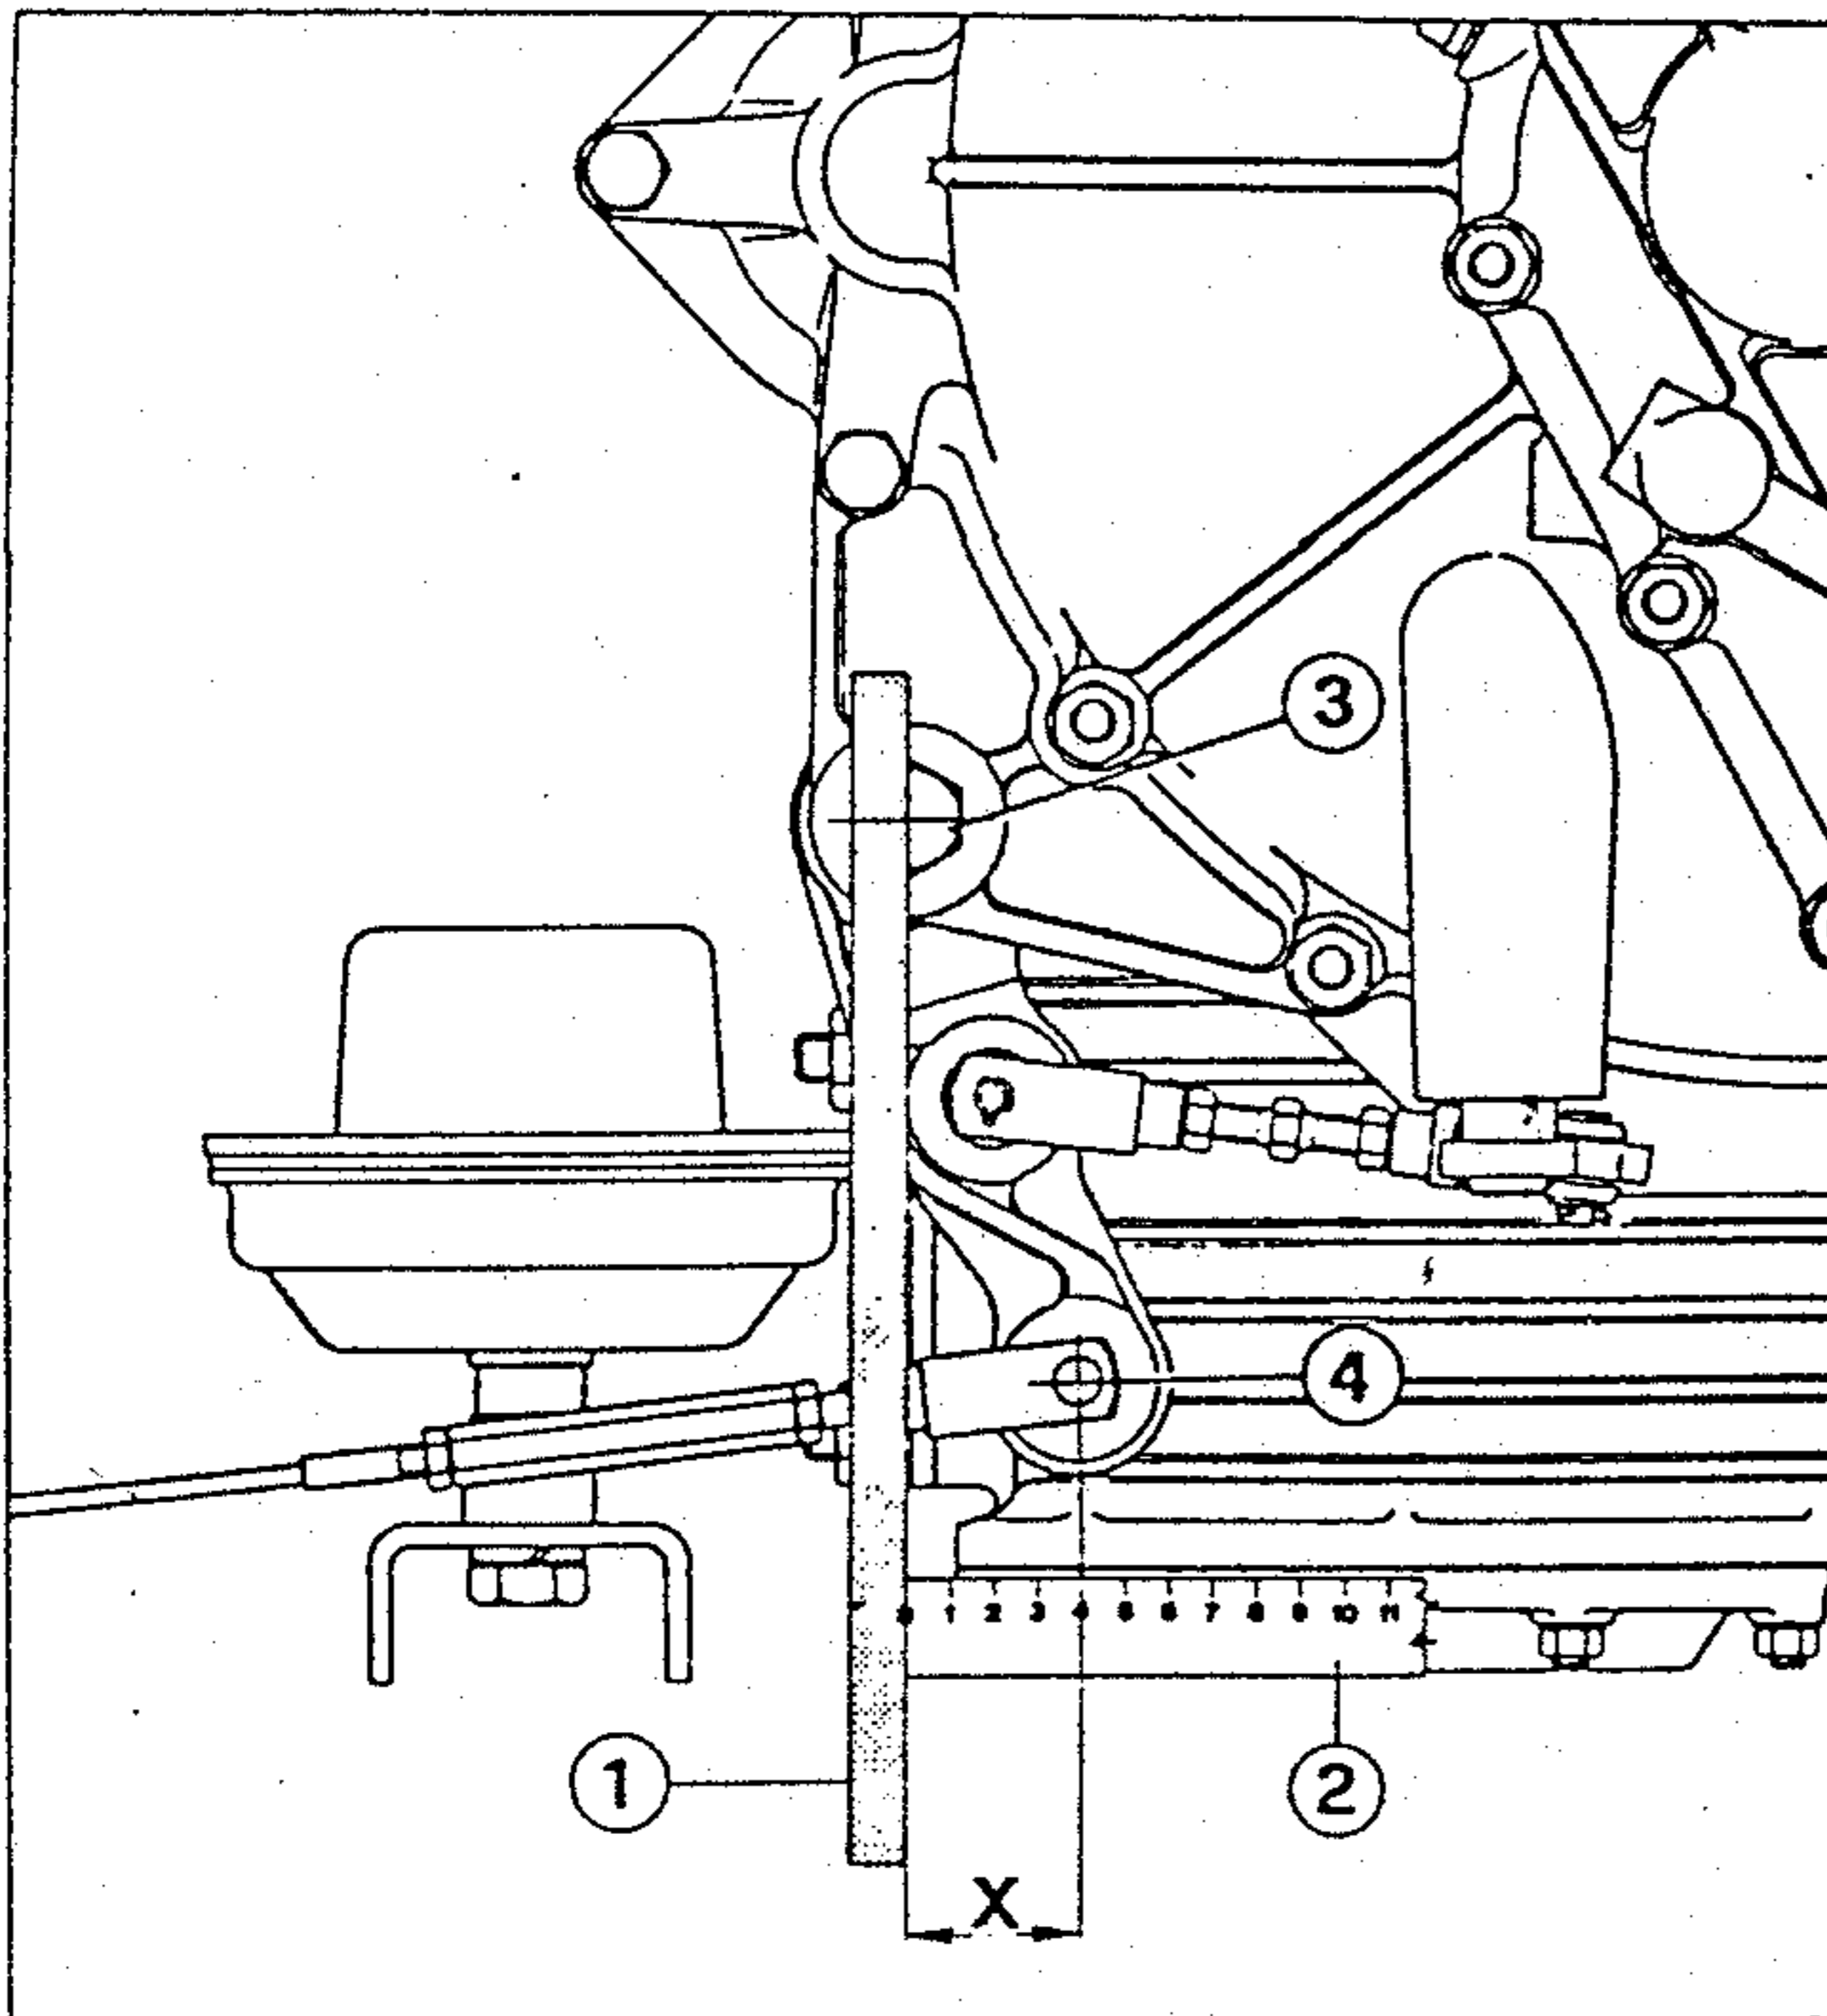
**Fig. 1**

- 1 - On the clutch housing, measure the distance X (Fig. 1) with a straight edge and a ruler, as shown by Fig. 1. The distance X must read between 40 and 45 mm.

1 - Straight edge, held vertical and positioned on the center of the bolt (3).

2 - Ruler, to which the center of the pin (4) must be referred, in order to read the distance X (X= 40 to 45 mm).

Should the distance X be found outside of the specified range, you shall:

- 2 - Adjust the threaded link C until the specified distance of 40 to 45 mm is achieved.

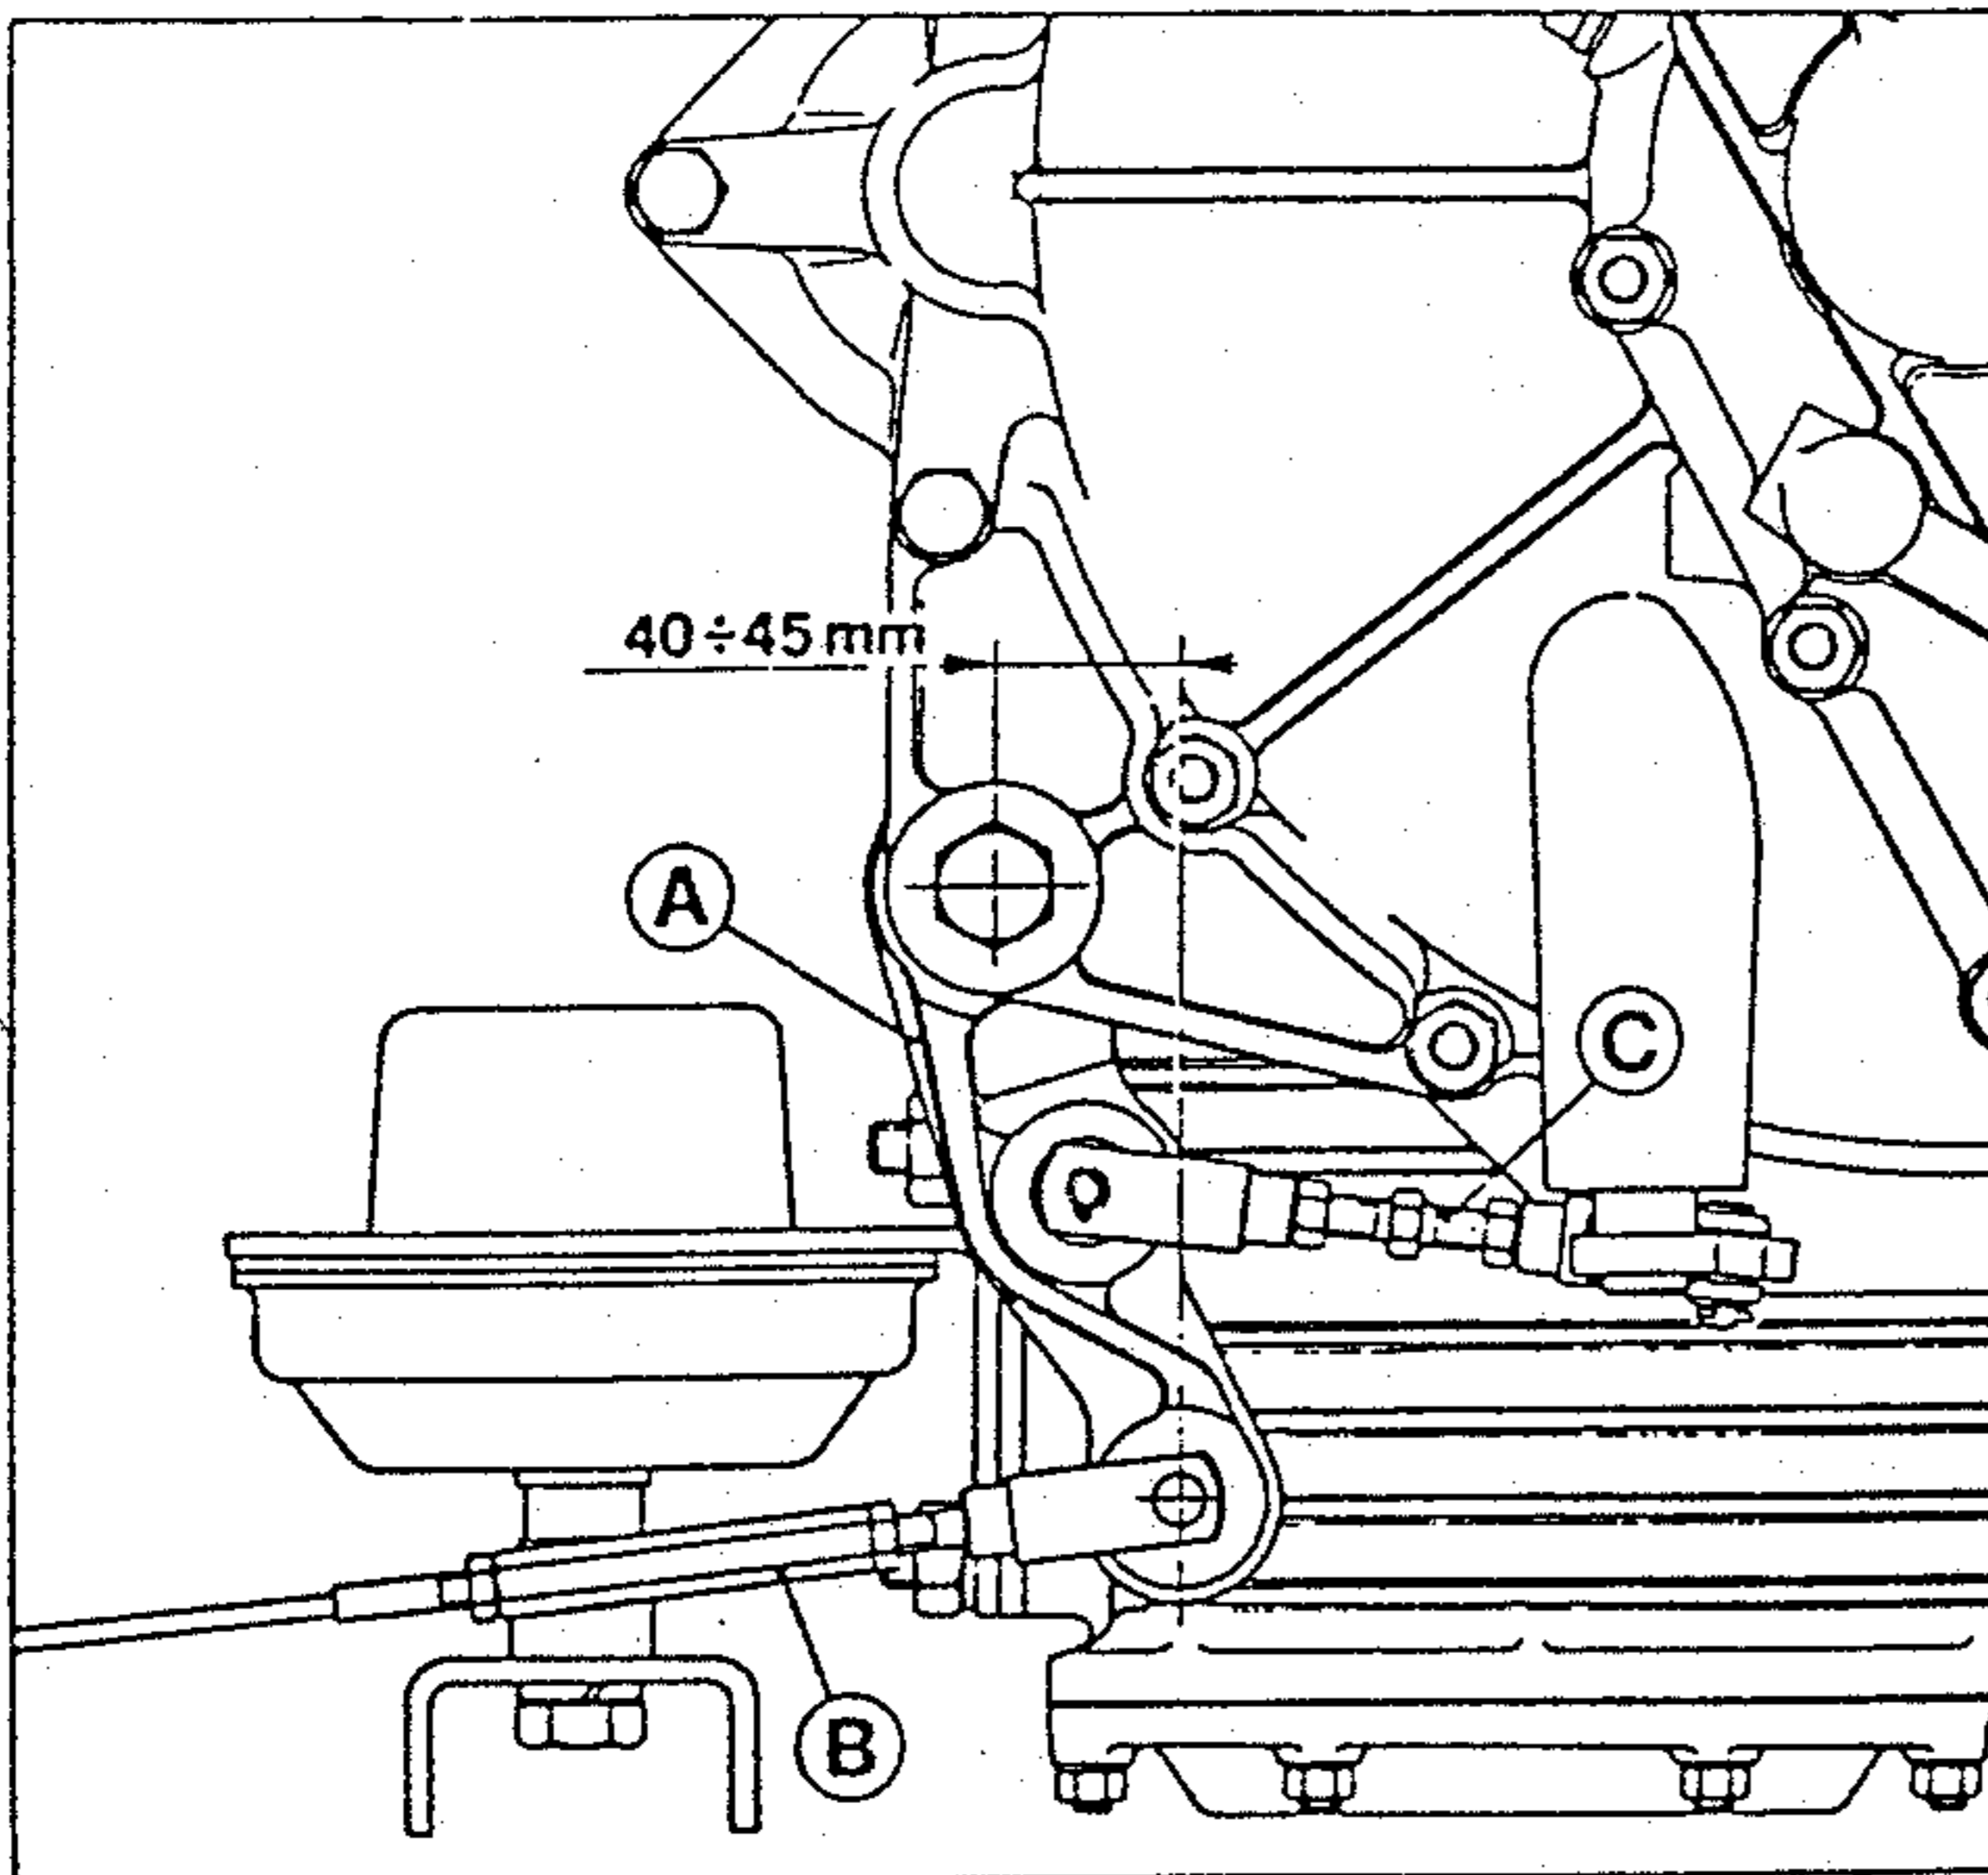
Fig. 2: Clutch Control Linkage on the Clutch Housing.

- A - Intermediate Lever
- B - Threaded connector for compensation of cables stretching.
- C - Threaded link for adjustment of system.

The clutch linkage positioning as shown in Figure 2 allows the release bearing and the related linkage to move backwards as the clutch disc wears normally, without any interference which would cause slipping of the clutch.

- 3 - Check the alignment of the clutch and brake pedals. If necessary, adjust only the threaded connector B (Fig. 2) in order to achieve the alignment.

WARNING: After the above mentioned checkings and adjustments are performed, you shall identify the car with a green painted marking on the threaded connector B.
