Service Bulletin

SB 30-1
11-29-79

SUBJECT: TRANSMISSION MAINSHAFT/CLUTCH BELL HOUSING
VEHICLES: DINO 308/GT4 AND 208/GT4

REISSUE OF TECHNICAL BULLETIN NO. 271, DATED 7/28/75

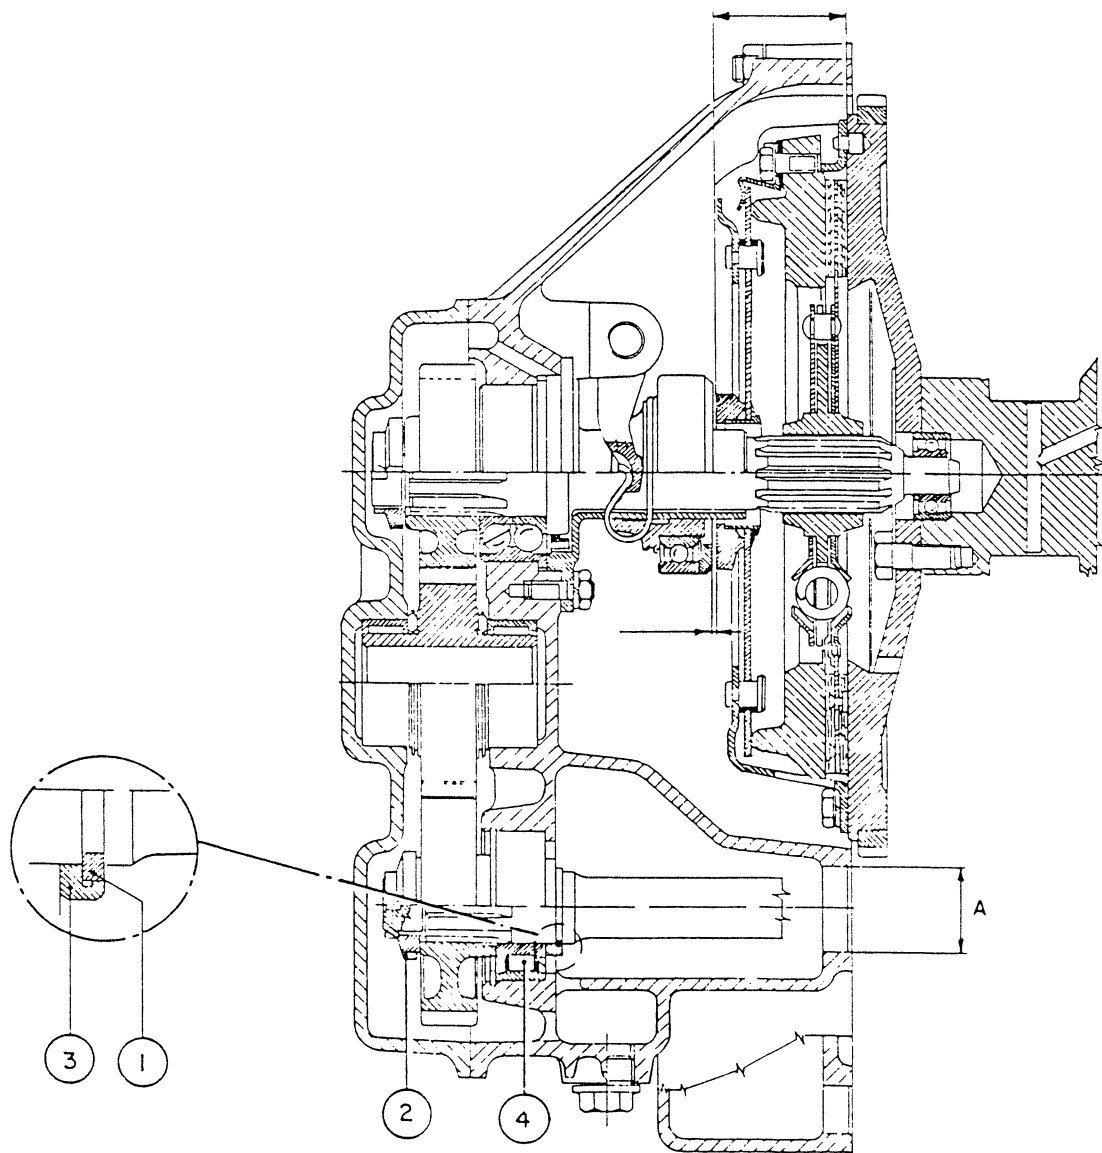
- A new stop ring assembly (No. 1 in illustration) has been installed.
 - this will prevent improper seating of the stop ring, when ring nut (No. 2) is tightened.
- Spacer (No. 3), Part No. 105134, has been modified by an addition of a containment groove.
 - Only the new modified spacer is to be used when replacement is required.
- On latest clutches, the diameter of hole (A) has been reduced.
 - It is impossible to remove the clutch bell housing with stop ring (No. 1) on the shaft.

To remove the clutch bell housing on modified vehicles, it is necessary to

- Remove bearing (No. 4) using tool No. AV 979.
- Remove stop ring (No. 1) using pliers for seeger rings.
- Remove clutch bell housing.
