## Service Bulletin

**SB** 21-7  
6/15/88

SUBJECT / OGGETTO: CLUTCH ASSEMBLY  
VEHICLES / VETTURE TIPO: TESTAROSSA

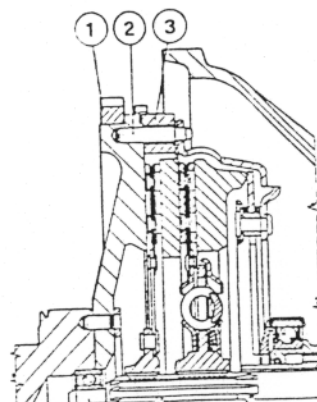
A new clutch unit which differs from the preceding unit in the centering on the flywheel by means of 3 studs is fitted. The new unit can also be fitted to preceding cars if the engine flywheel is also replaced. Cars with C.N. 73701-73735-73737-73791-73793-73873, all in the SWISS VERSION, are still fitted with the premodification units.

OLD PART NO. / PARTICOLARI SOSTITUITI			NEW PART NO. / NUOVI PARTICOLARI		
Fig.	P. Number Disegno	Description / Denominazione	Fig. Rif.	P. Number Disegno	Description / Nuovi Particolari
1	130644	Engine flywheel-not for USA & SWITZERLAND	1	136023	Engine flywheel-not for USA & SWITZERLAND
1	125780	Engine flywheel for USA & SWITZERLAND	1	136025	Engine flywheel for USA & SWITZERLAND
3	124102	Spacer	2	136009	Centering stud
-	124680	Complete Clutch	3	136007	Spacer
				136006	Complete clutch not for SWITZERLAND
				135076	Complete clutch for SWITZERLAND
